# Cal Certified Inspections

## Confidential Inspection Report

**12345 Pacific Coast Highway, Malibu, CA 90265**  
**Inspection prepared for: John Smith & Jane Smith**  
**Date of Inspection: 1-5-2022 Time: 10:30 a.m.**  
**Age of Home: 2010 Size: Approximately 4812 square feet**  
**Weather: Sunny**

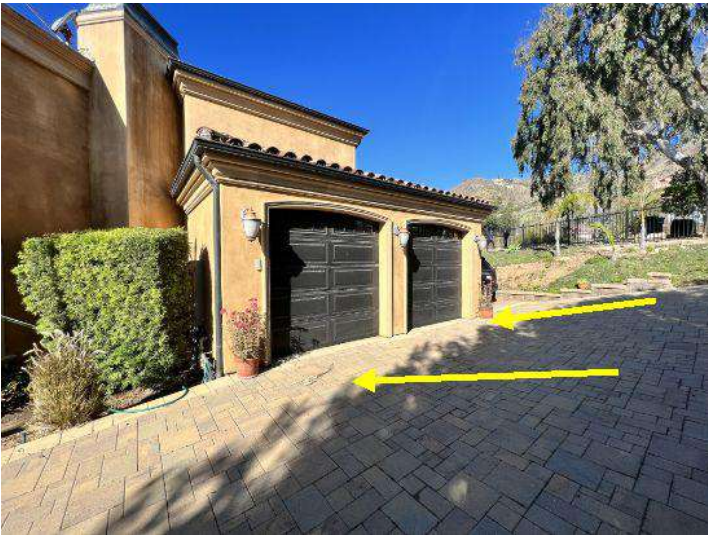
- Lot grading and drainage have a significant impact on a building, simply because of the direct and indirect damage that moisture can have on the foundation. It is very important, therefore, that surface runoff water is adequately diverted away from the home. Additionally, the property was situated on a steep hillside/canyon and it would be prudent to have a geologist fully evaluate and offer recommendations for improvement, if any is needed.
- The driveway was sloped toward the garage(s). Evidence of water infiltration was observed inside both garages. Ideally, a drain should be installed in front of both structures in order to help prevent potential water damage during rain episodes.

Water may drain toward the garage doors

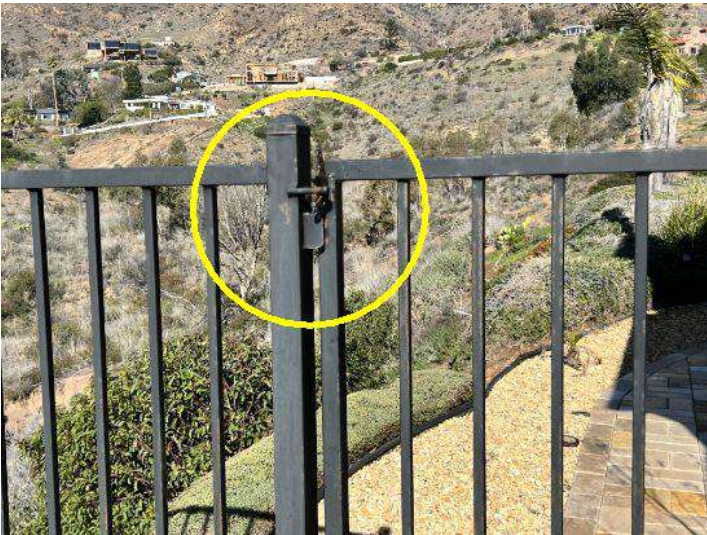
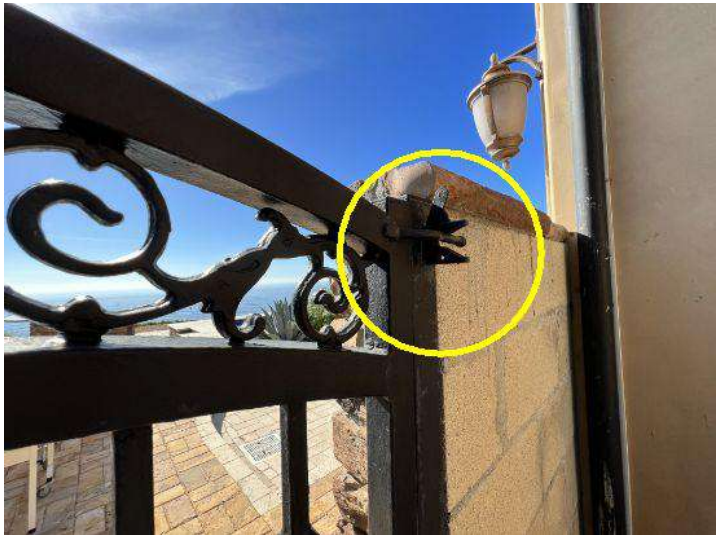
The metal gates needed repair

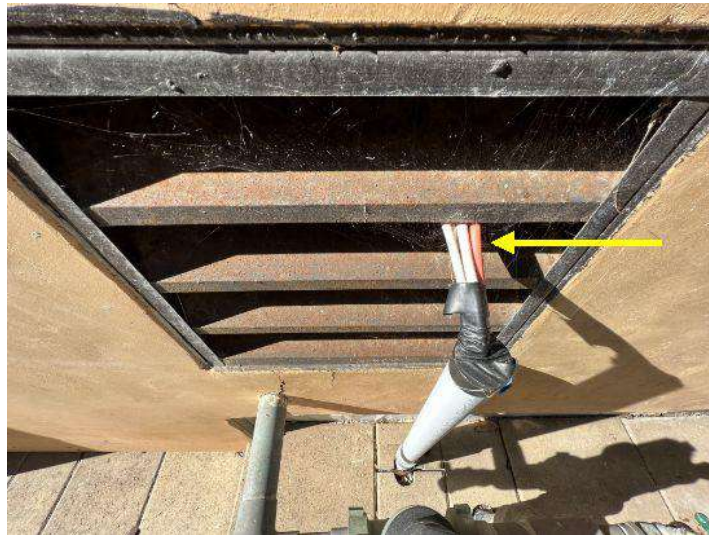
- See "Grounds-Electrical-GFCI" notes.
- There were electrical lines observed on the left side of the main house. The lines were strung through a sharp metal vent. Safety concern. I recommend further evaluation and recommendations for repair by a qualified electrician.

Electrical wires installed over a sharp metal vent fin

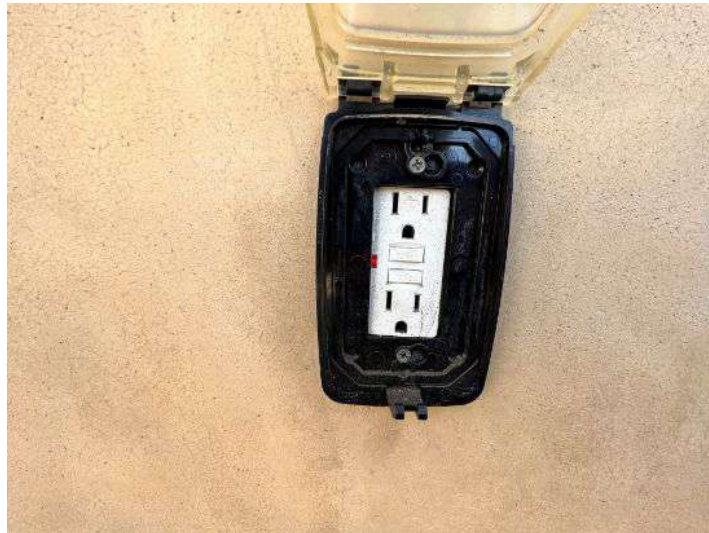
- The GFCI receptacle on the left side of the main garage was damaged and did not function properly. I recommend further evaluation and repair by a qualified electrician.

This exterior electrical receptacle was defective

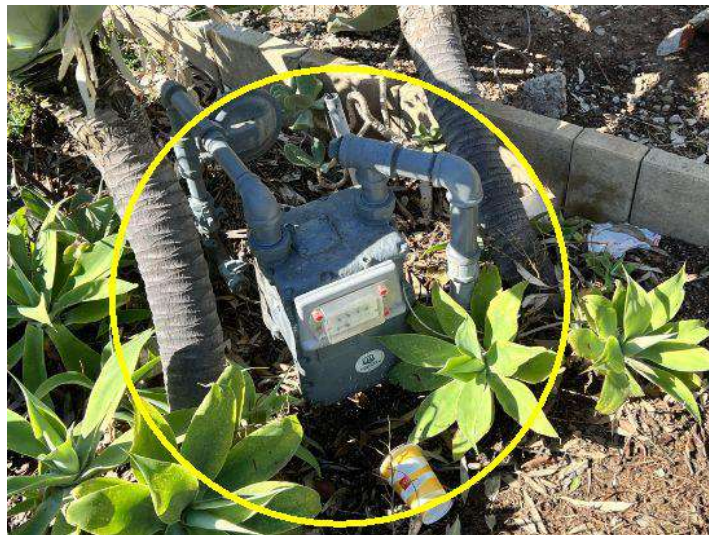
- The gas meter did not include a seismic shut off valve, which is a requirement in the City of Malibu. I recommend correction as needed.

The gas meter was missing a seismic shut off valve

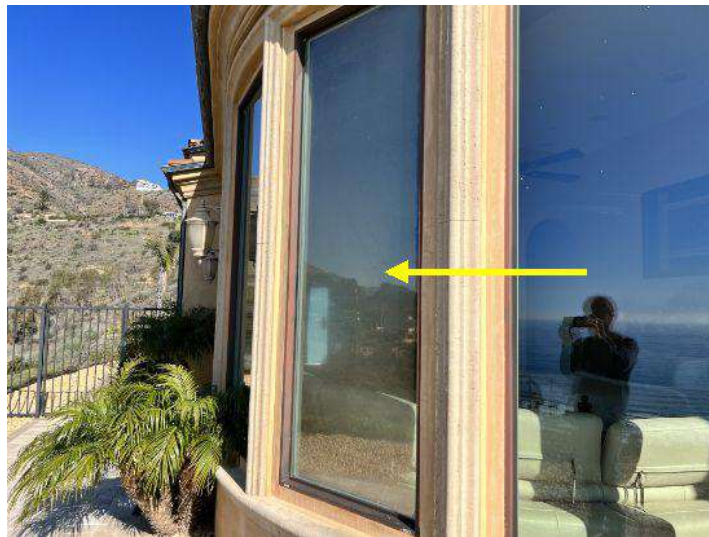
- Condensation was present in some double-paned windows, which was an indication of a broken seal between the glass panes. I recommend further review of all windows and repair/replacement (where needed) by a qualified window contractor.

"Fogged" window shown here

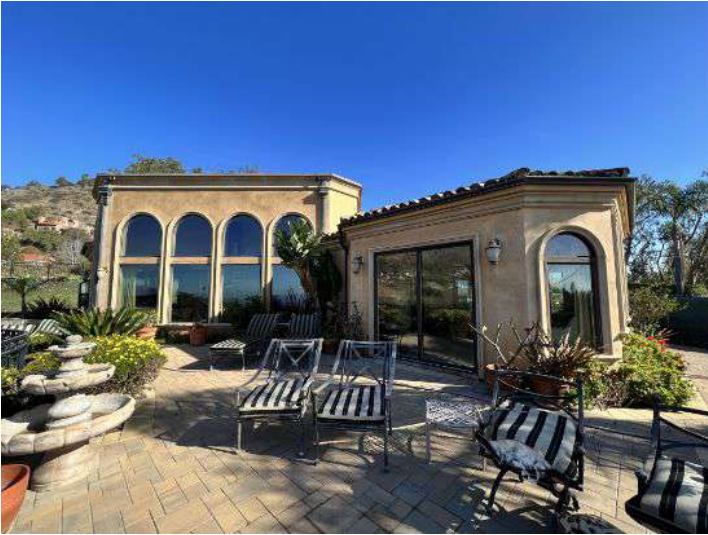
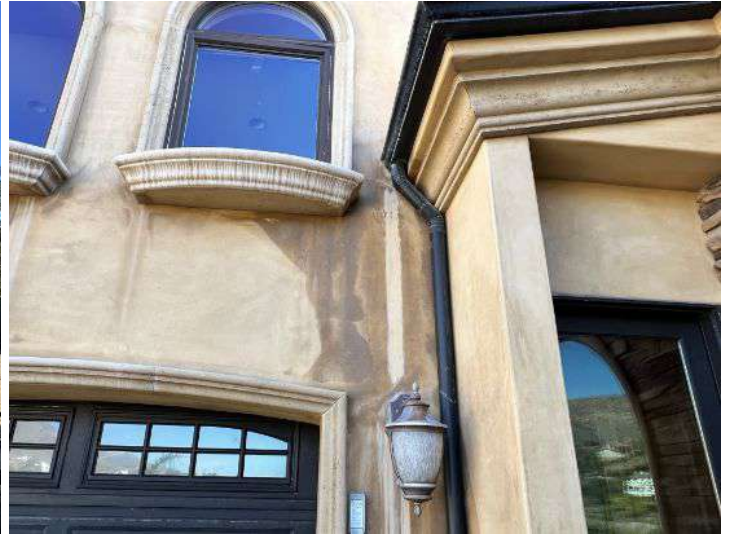
- The smooth plaster was discolored above the garage(s) and some exterior areas had small cracks which may expand if not repaired as recommended. I recommend further evaluation and recommendations for repair/correction by a qualified specialist.

Discolored plaster should be evaluated by a specialist

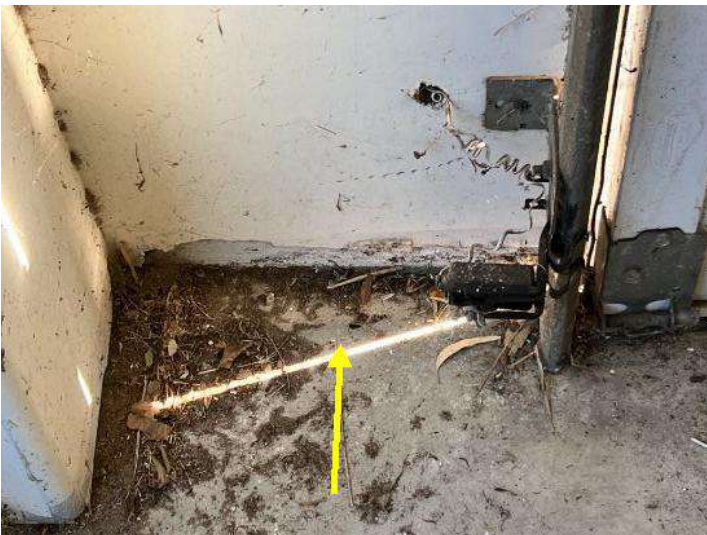
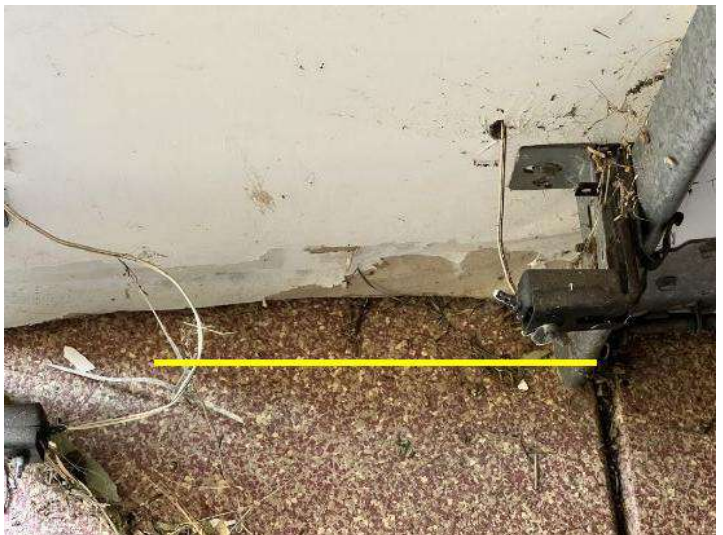
- Evidence of water intrusion on the bottom of the walls near the garage doors. Refer to "Outside House-Grading" notes.

Water infiltration had damaged some garage walls

The main house garage also had indications of water intrusion/damage on the drywall

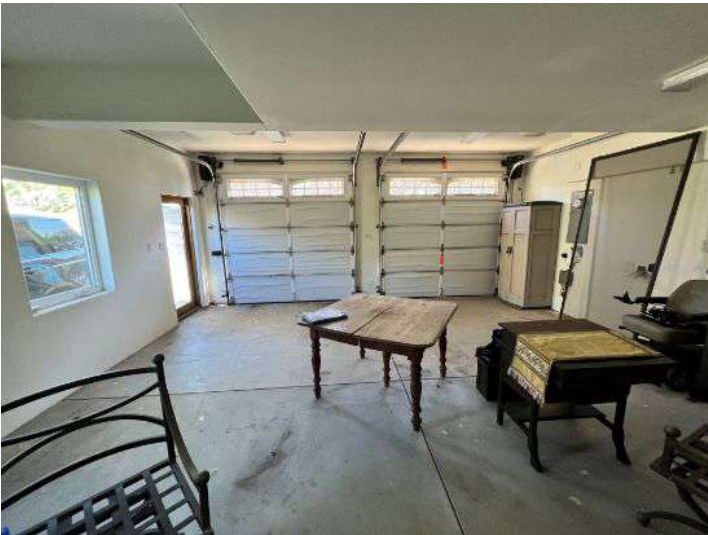
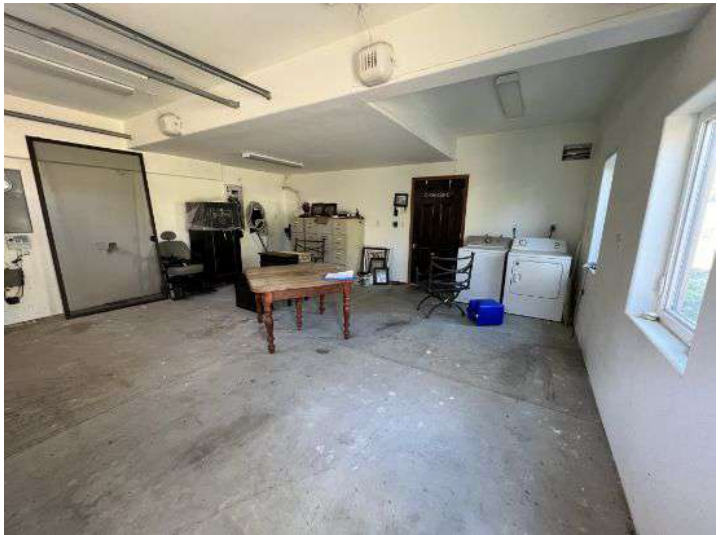
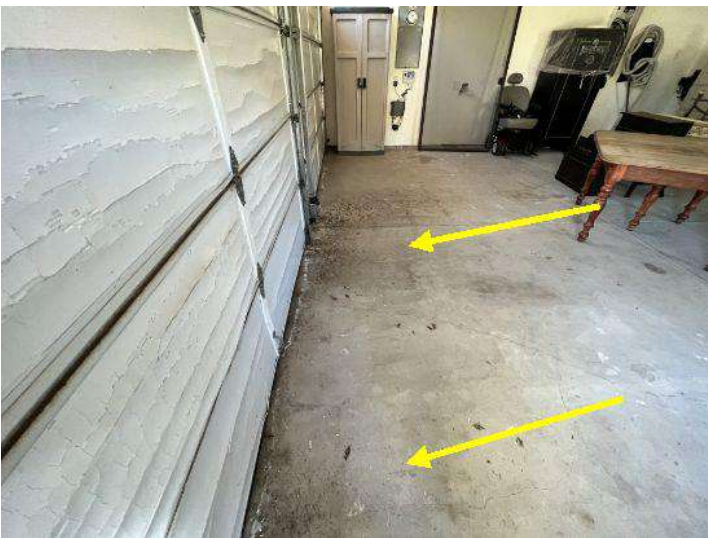
- The garage floor had numerous cracks, although none appeared larger than 1/4 inch.
- Indications of water infiltration was observed on the floors of both garages. Water infiltration may have been caused by inadequate drainage and/or a poor seal on the bottom of the garage doors. I recommend further evaluation and repair by a qualified tradesman.

Evidence of water infiltration

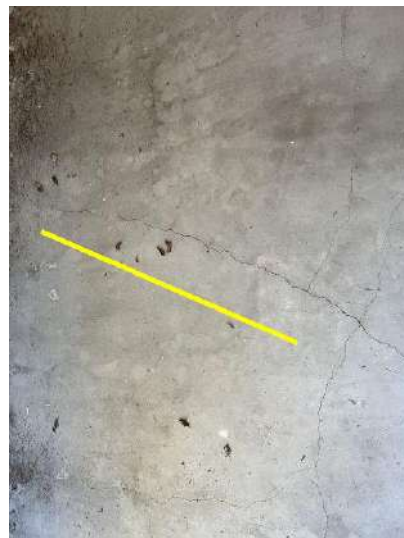
Some hairline cracks on the concrete garage floor

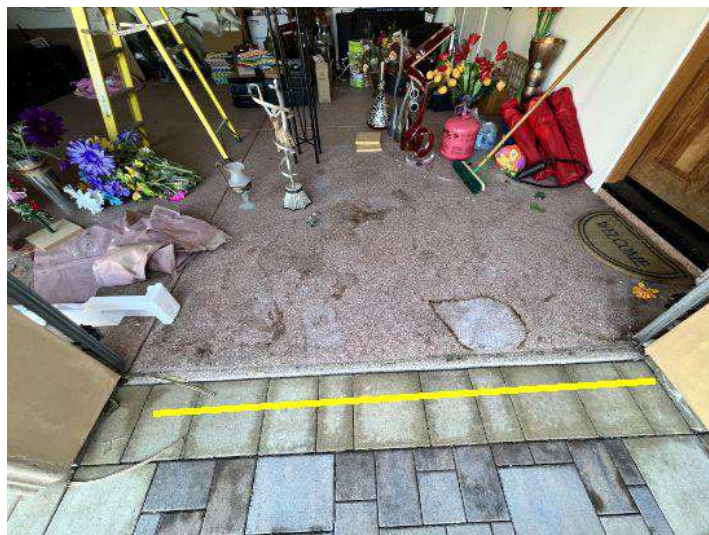
Evidence of water infiltration on the main garage floor

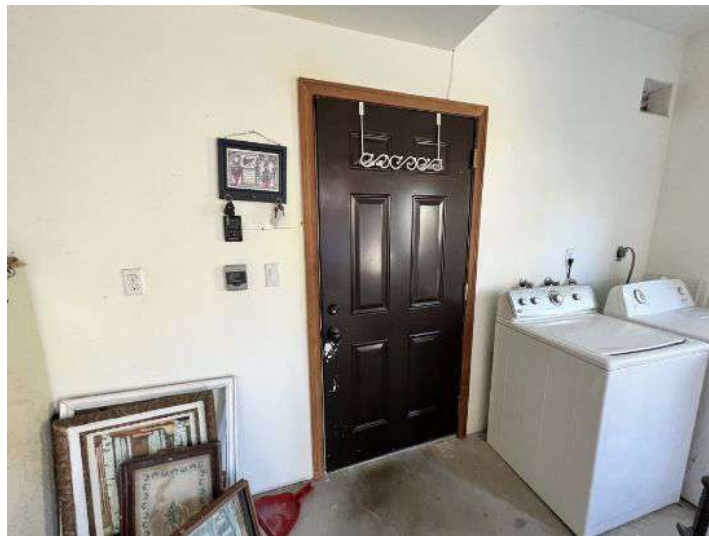
- The guest house fire door leading from the garage into the house did not completely self close and latch as required. The door should automatically close and latch in order to help prevent exhaust fumes, smoke, fire, etc., from entering the living area. I recommend a qualified contractor correct as needed before the close of the escrow contingency period.

The guest house fire door should completely self close and latch for safety

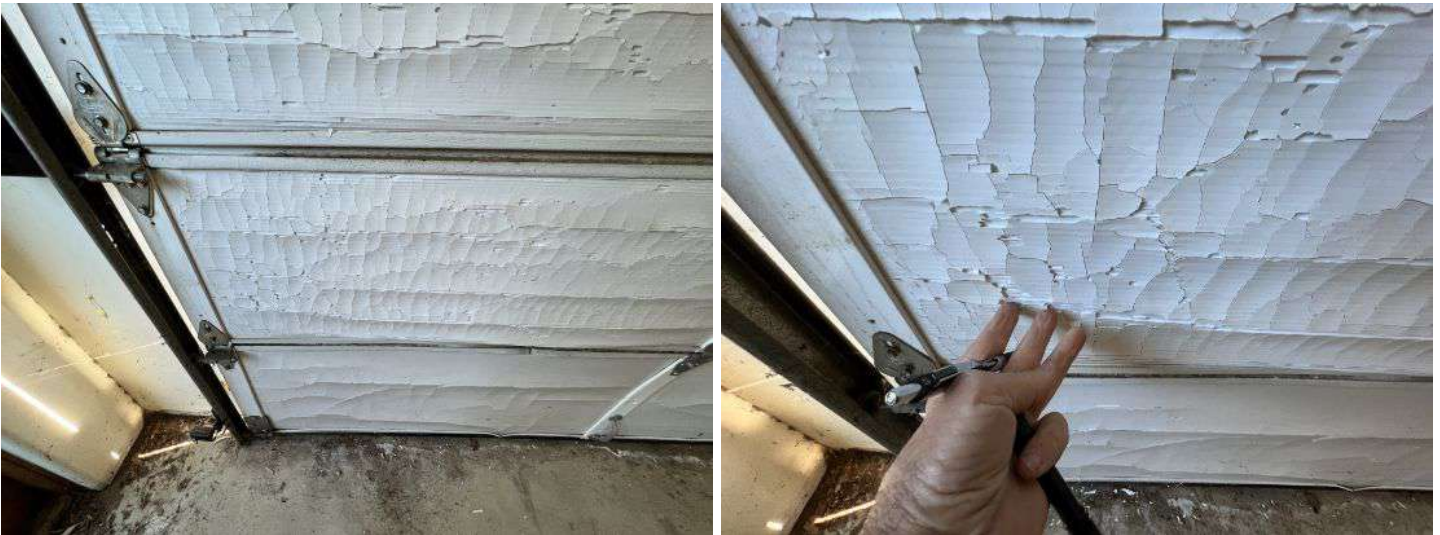
- The garage doors on the guest house were damaged. The insulation on the inside of the doors had indications of water damage and the material was decomposing. I recommend further evaluation by a qualified contractor.

Damaged guest house garage doors

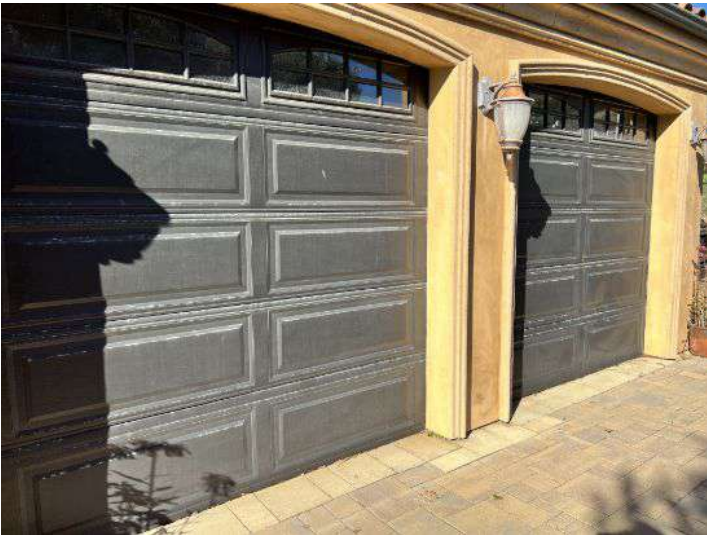
- The left (north) garage door of the main house and two guest house garage doors did not open when tested. The garage door openers did not appear to operate. I recommend further evaluation and repair by a qualified specialist.

Unable to activate the guest house garage doors.  
Remote control may have been needed

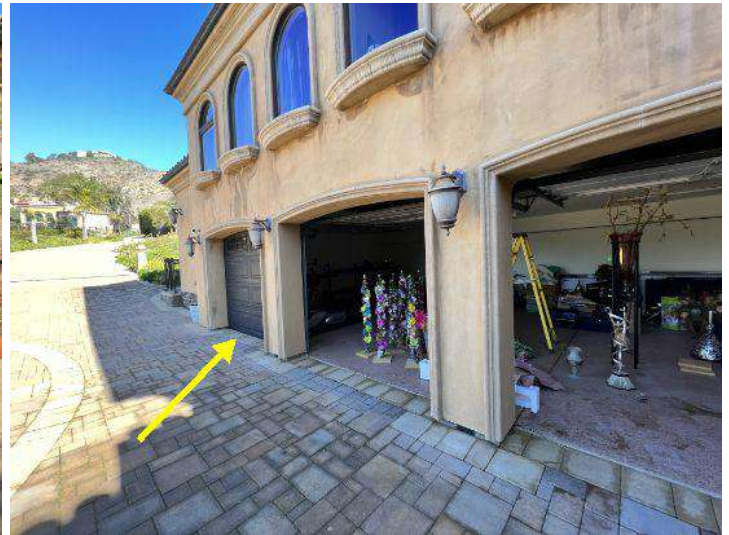
Unable to open this door

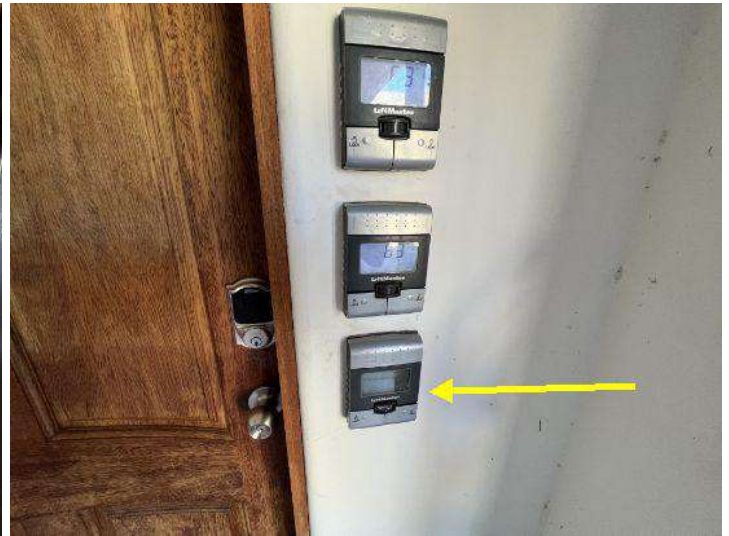
This opener did not operate the north door

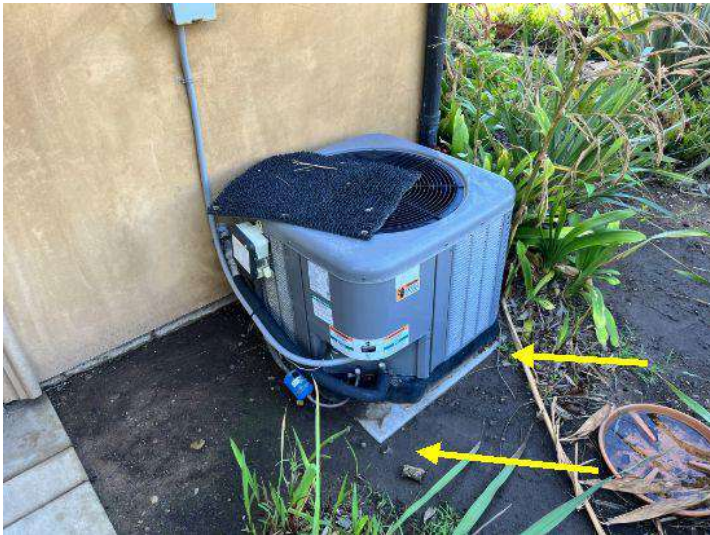
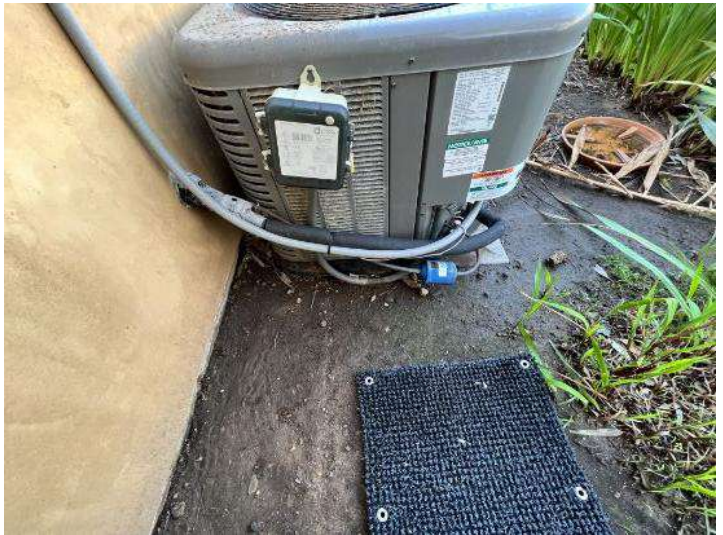
- The A/C condensers were not strapped to the bases. Safety hazard in case of sudden movement, i.e, earthquake. I recommend leveling and strapping as needed for safety.
- The base for the guest house A/C unit was covered with dirt/mud and was not elevated as required. Correction recommended.

The guest house A/C unit should be raised off the ground and strapped to the base

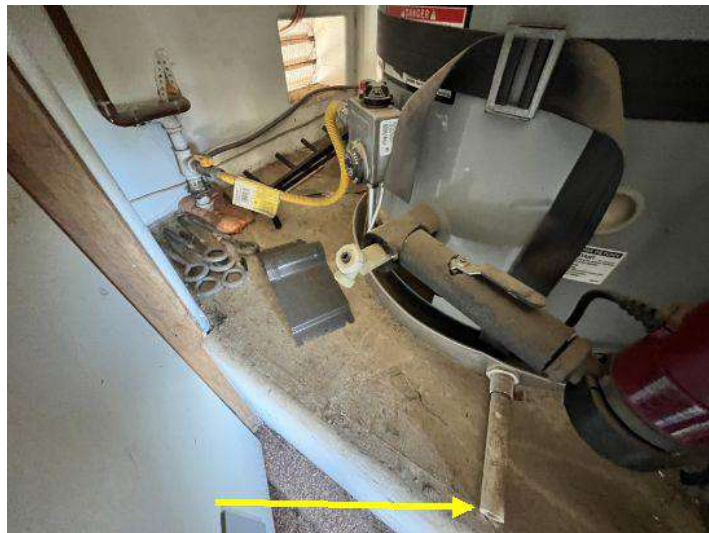
- The water heater drain pan did not have a long extension pipe to carry water to the exterior of the garage. In the event of water heater failure, water would discharge onto the water heater base, then onto the floor and potentially cause damage. I recommend further review and correction by a qualified specialist.

A drain pan extension pipe is recommended

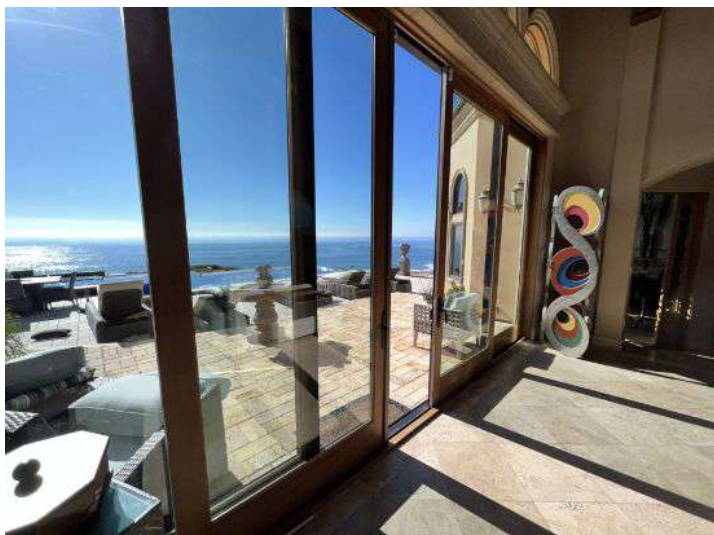
- Some sliding glass doors did not latch properly. I recommend repair as needed.

Several patio doors needed repair

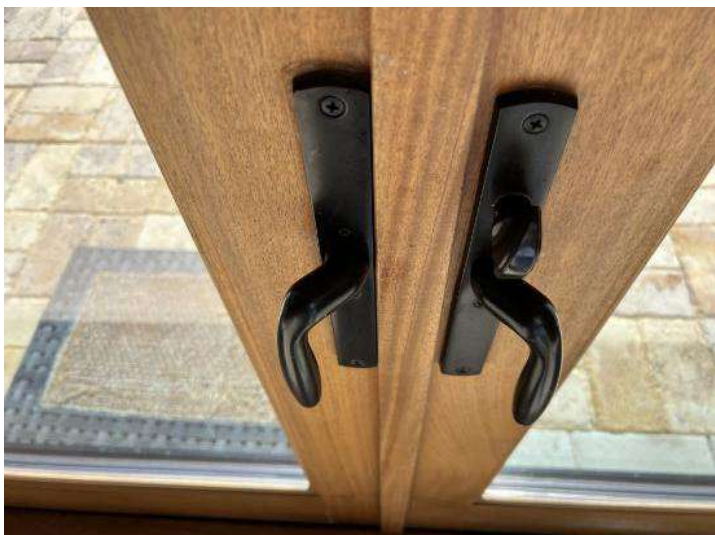
These patio doors did not latch and lock

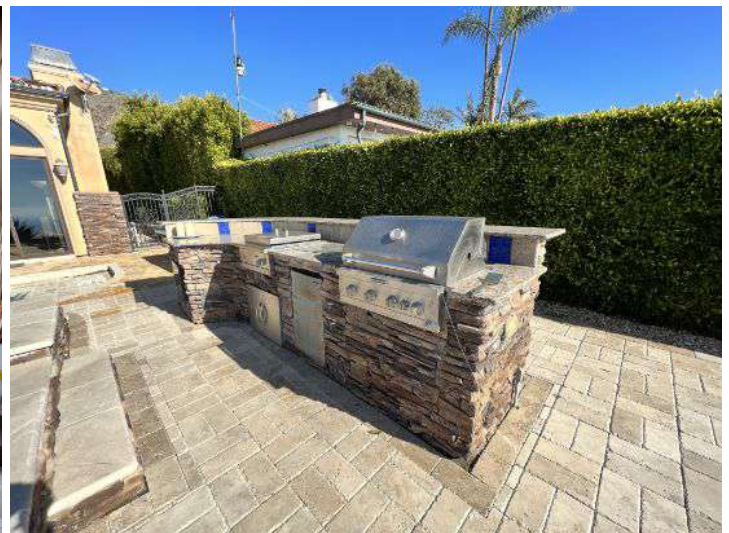
- The gas cook tops for both houses operated normally when tested.
- The pool area included an outdoor kitchen with a gas grill. The ignitor button for the grill did not operate when tested. Repair recommended.

The ignitor button did not operate

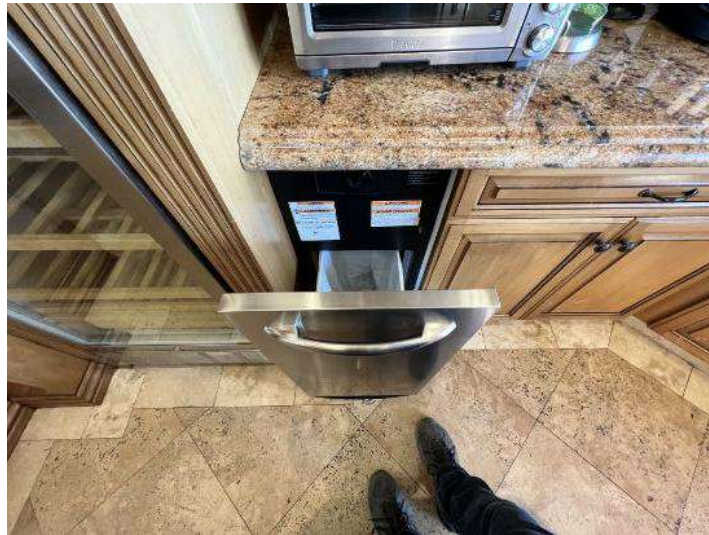
- Did not operate properly. Recommend repair or replacing.

Unable to activate the trash compactor

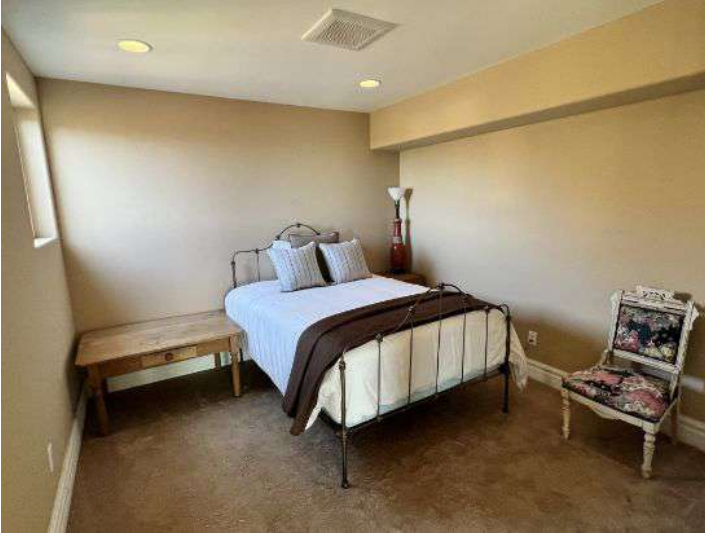
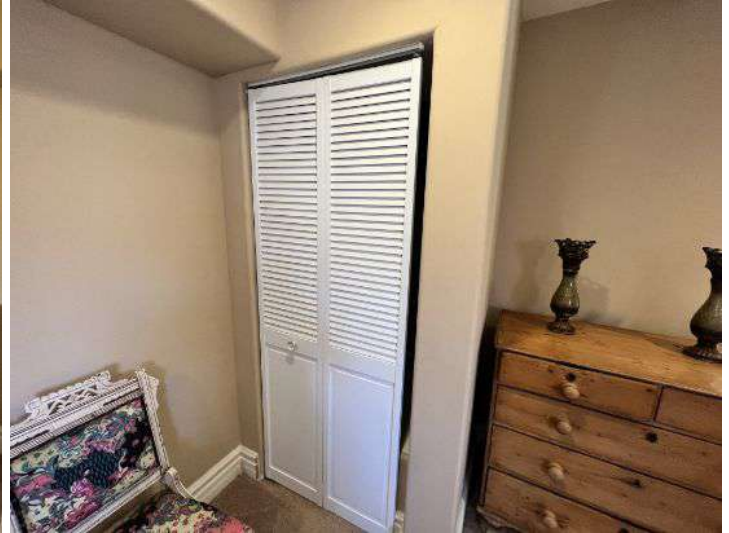
- The closet door in the guest house loft did not fit properly. Replacement recommended.

This door did not fit the opening

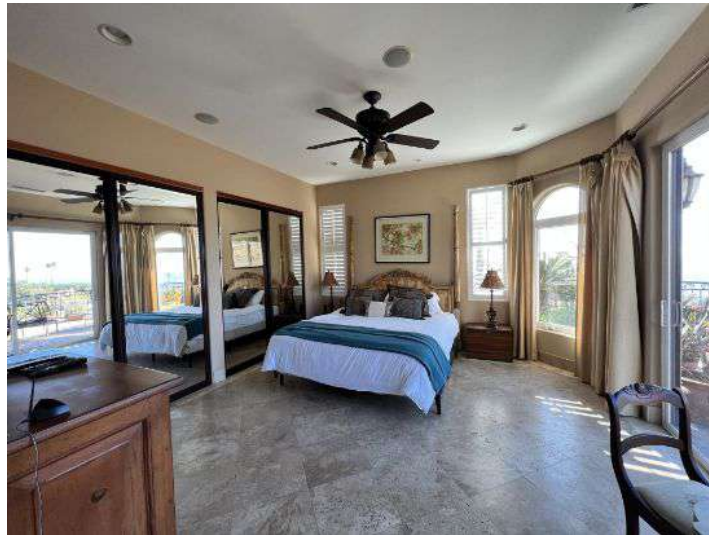
- Some smoke detectors were "chirping", which was an indication of a low battery. Replacement recommended.

Battery replacement needed in some smoke detectors

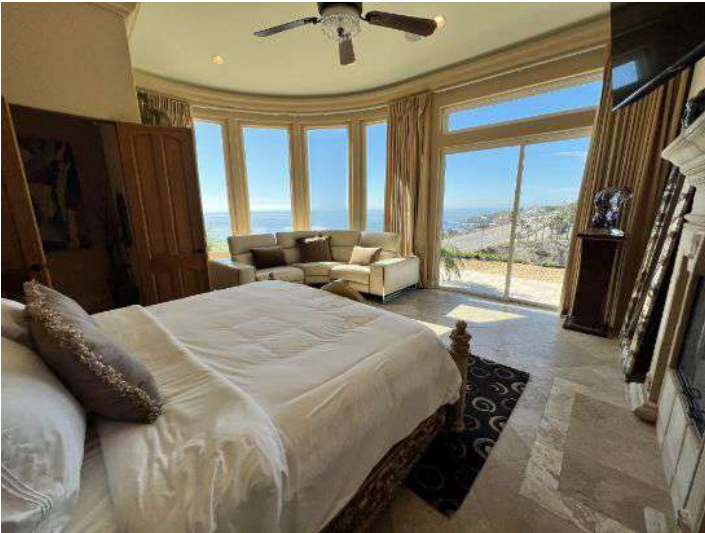
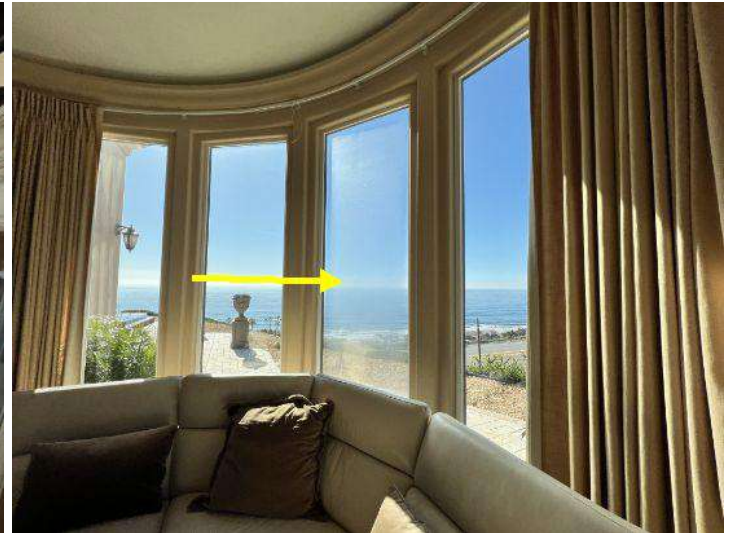
- Fog/condensation observed in one master bedroom window, which was an indication of a failed seal. Repair or replacement as necessary.

"Fogged" window in the master bedroom

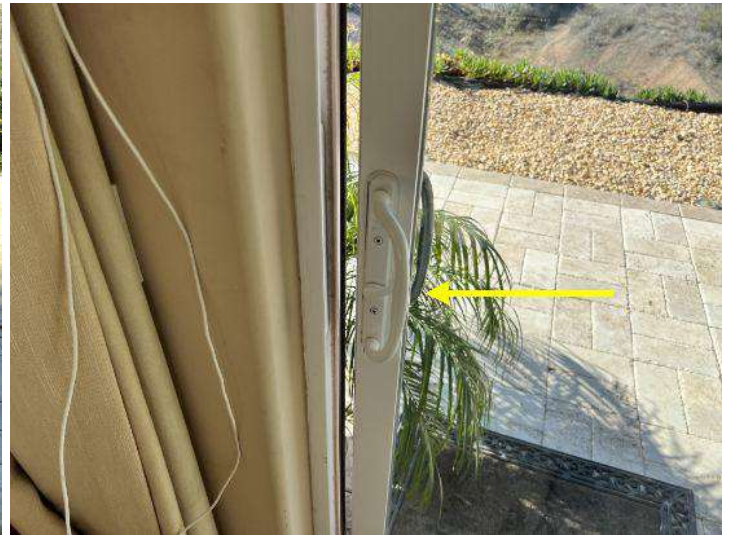
The master patio door did not latch and lock

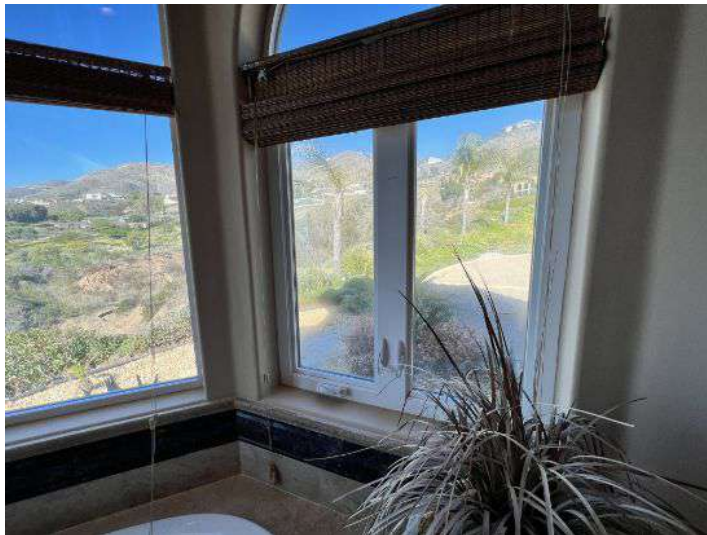
- Refer to "Outside House-Exterior Areas Windows" notes.
- At least one master bathroom window showed sign of loss of seal/condensation, I recommend repair or replacement to provide energy savings and prevent hazed window from limiting view out of the window.

"Fogged" master bathroom window(s)
