Cal Certified Inspections

Confidential Inspection Report

29031 Palm Drive, Calabasas, CA 91302
Inspection prepared for: Robert Black & Robin Black
Real Estate Agent: Gregory White - Calabasas Realty

Date of Inspection: 3/11/2022 Time: 10:00 a.m.
Age of Home: 1991 Size: Approximately 7493 square feet
Weather: Sunny

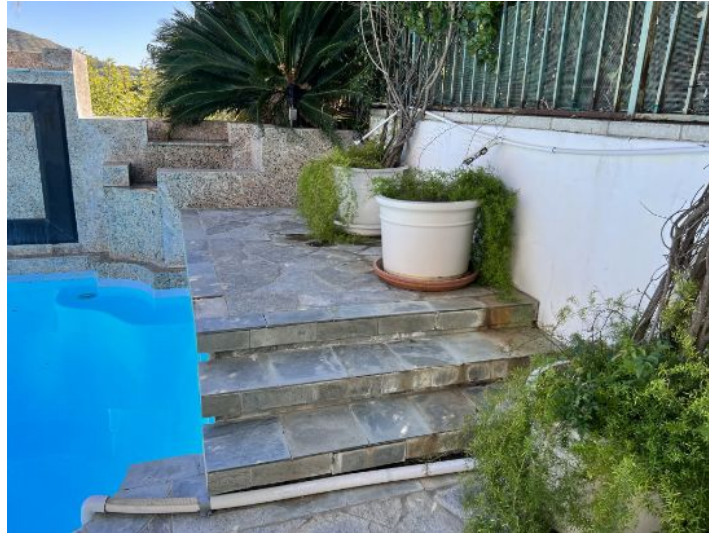
- Hand rails were missing on the steps leading to the pool/water feature, which was a safety hazard. I recommend further review and correction by a qualified contractor.

Hand rail recommended here

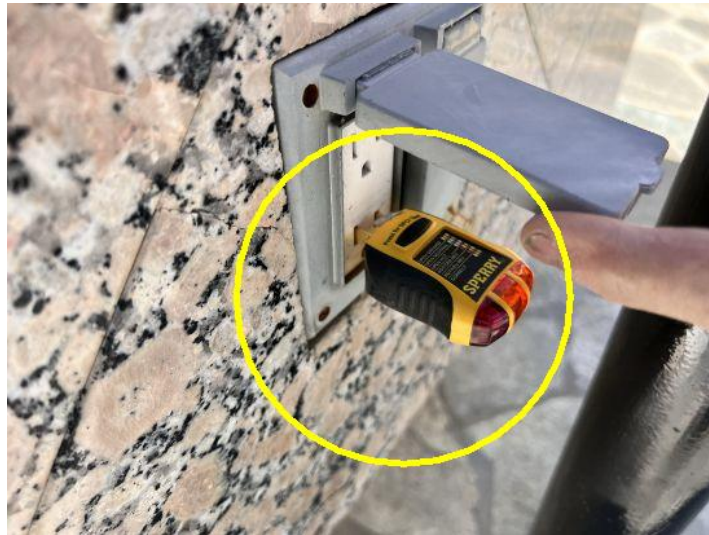
Defective receptacle on the outdoor kitchen island

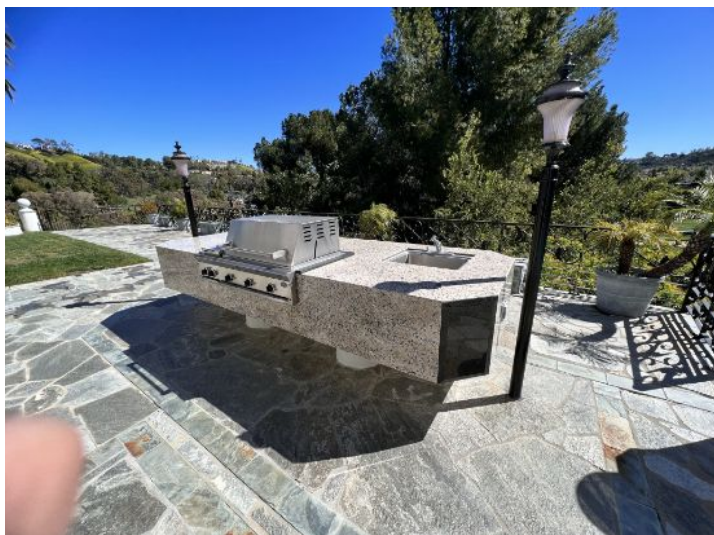
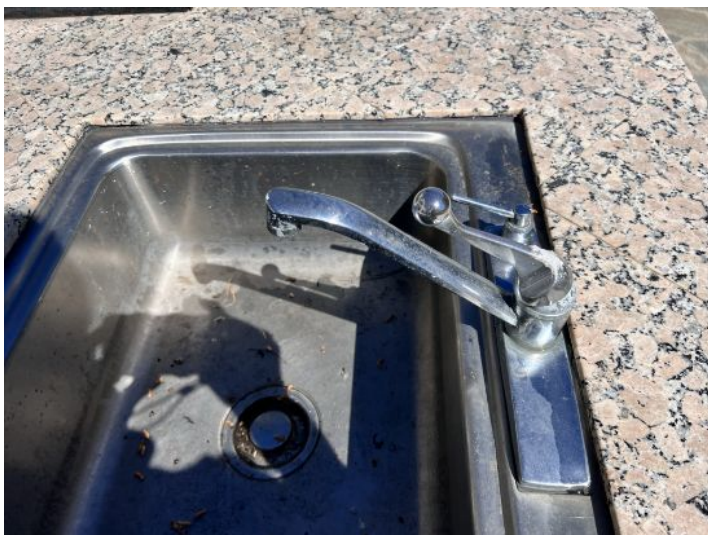
- Sewer line—Due to the age of this home, I recommend a sewer line inspection. A separate inspection will show the condition of the buried sewer line from the home to the city main. Items such as tree roots, broken drain pipes, and other obstructions may be revealed.
- The outdoor kitchen included a sink. The sink faucet was defective and leaking when tested. Repair recommended.

Defective sink faucet

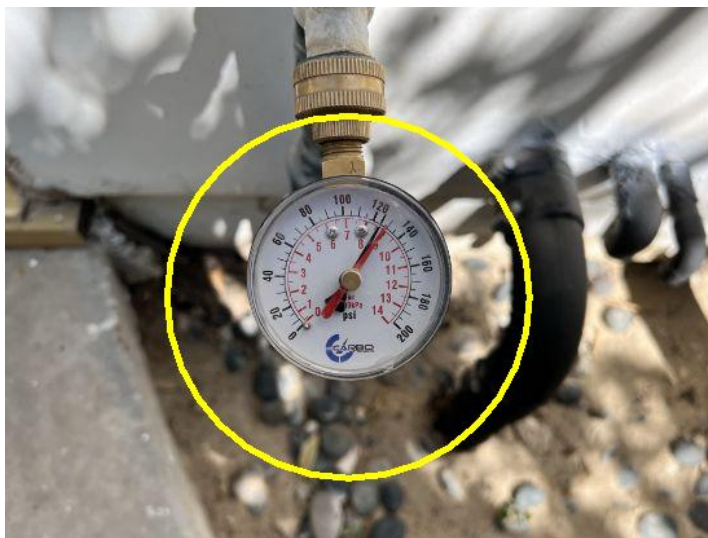
- 120 psi noted at the time of the inspection, which was too high. I recommend contacting a plumber adjust the water pressure to recommended levels of 60-70 psi.

Water pressure was too high

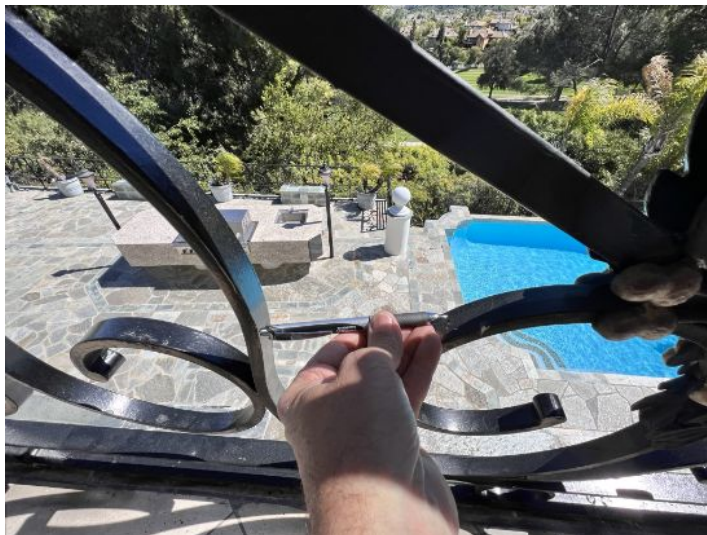
- The decorative metal balcony railings were more than 4" apart, which may be a safety concern for pets/children (falling through). I recommend correction as needed.

Wide gaps on the master balcony railing may be a hazard for kids and pets

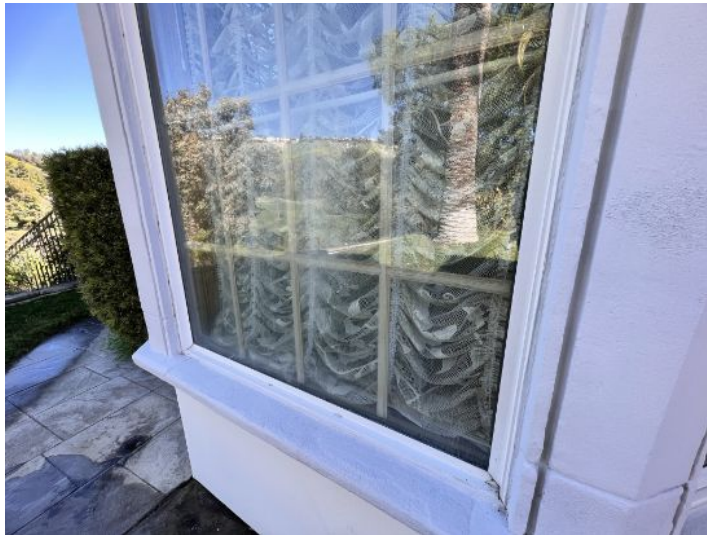
- Condensation was present in some double-paned windows, which was an indication of a broken seal between the glass panes. I recommend further review of all windows and repair/replacement (where needed) by a qualified window contractor.

The front windows appeared to be "fogged"

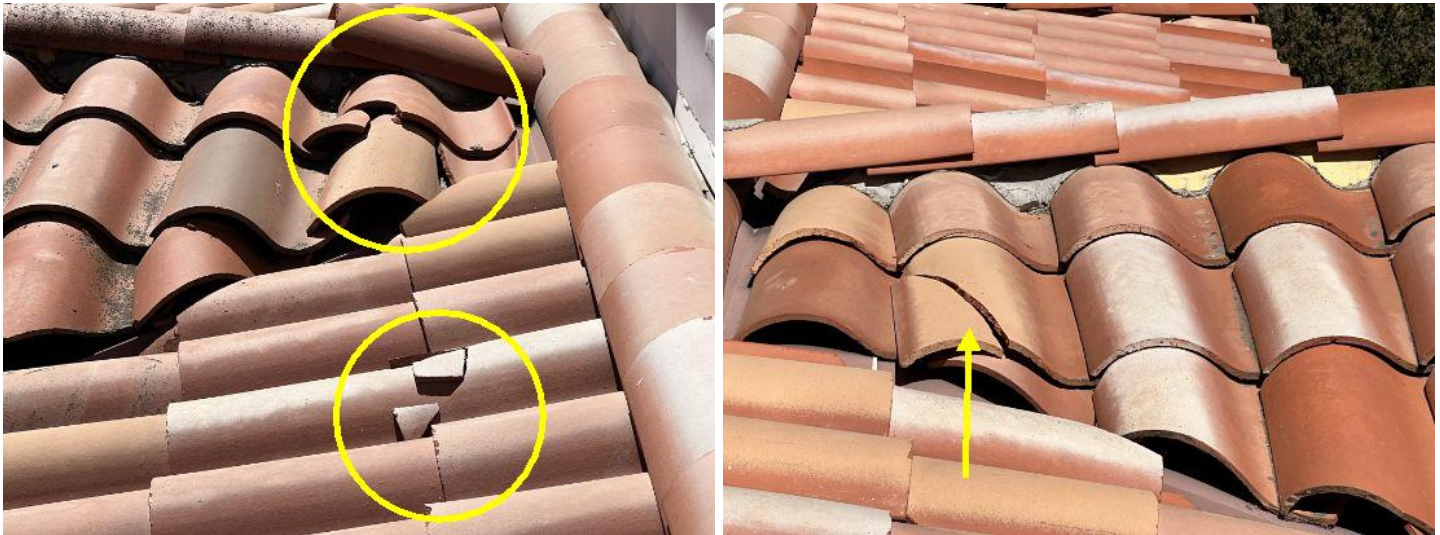
- Repaired areas and cracked/damaged roof tiles were observed on the roof. There were indications of water damage in the interior ceiling(s) which may have been caused by roof damage. I recommend further review by a qualified roofing contractor.

Damaged roof tiles

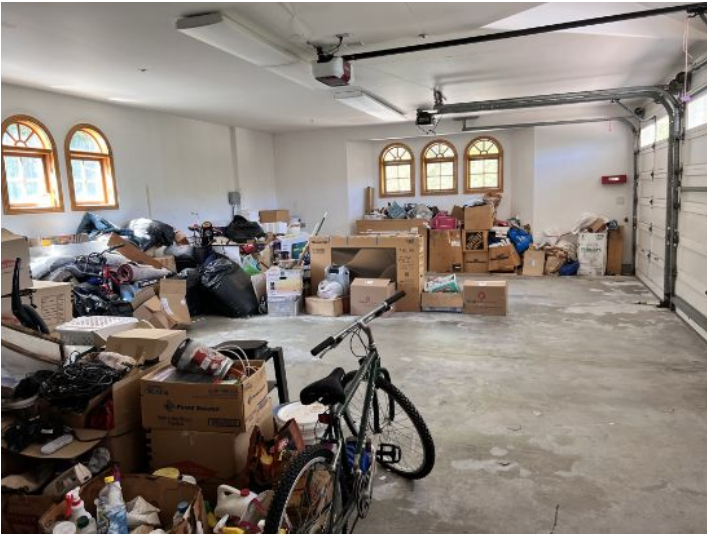
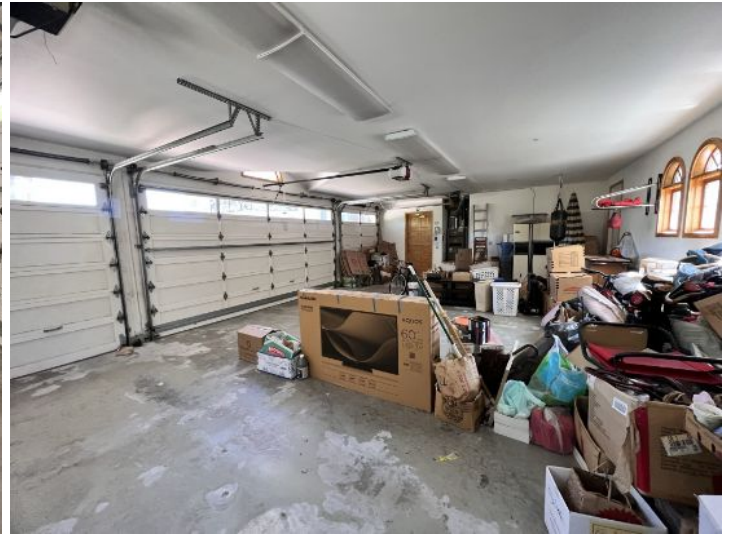
- The concrete floor was damaged near the garage door (see picture). Water infiltration into the garage may be possible if not repaired as needed.

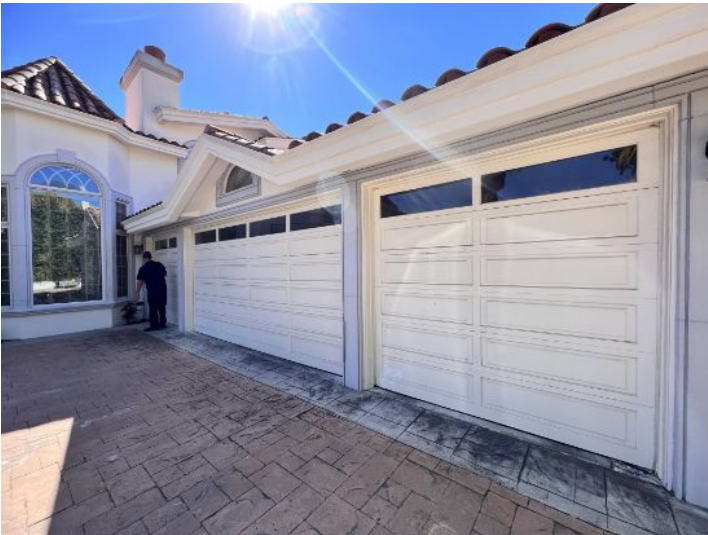
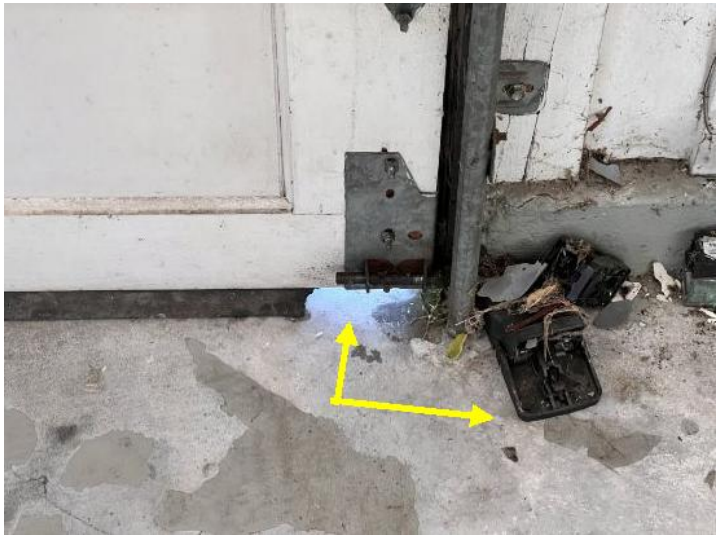
- The rubber weatherstripping under the (right side) garage door was partially detached/damaged. Air gaps observed which may allow water and/or pest infiltration. I recommend further review and repair by a qualified specialist.

Damaged weatherstripping and detached sensor shown here

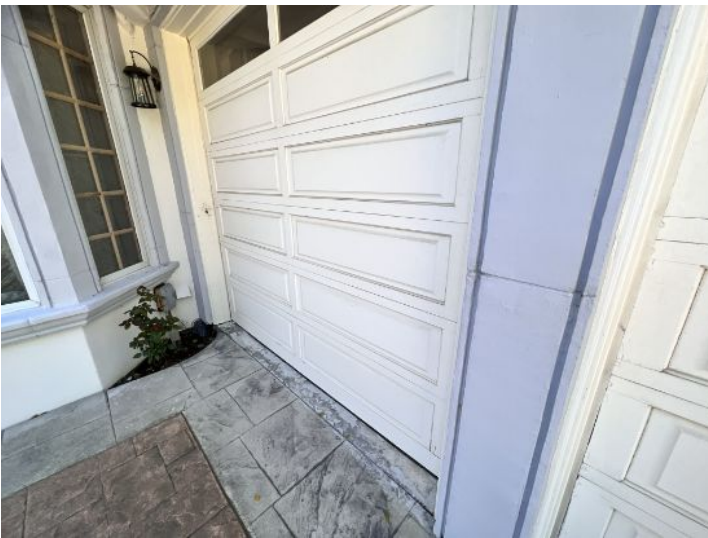
- The smaller garage door opener was unplugged and not operational. Correction recommended.

This door opener was not operational

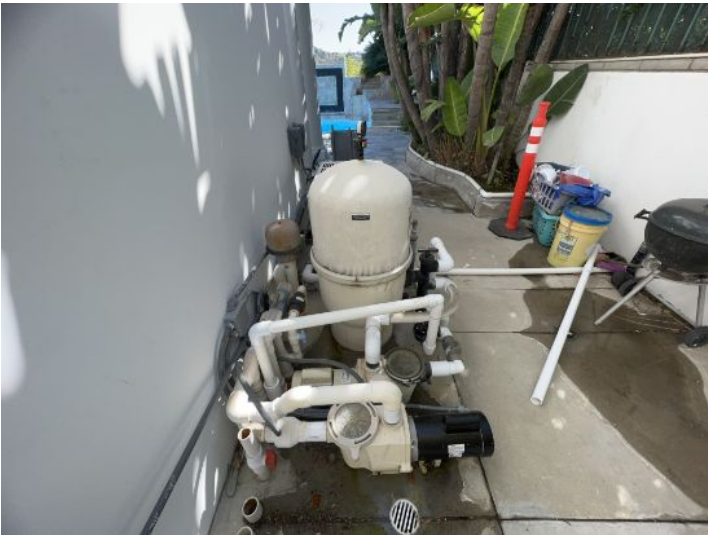
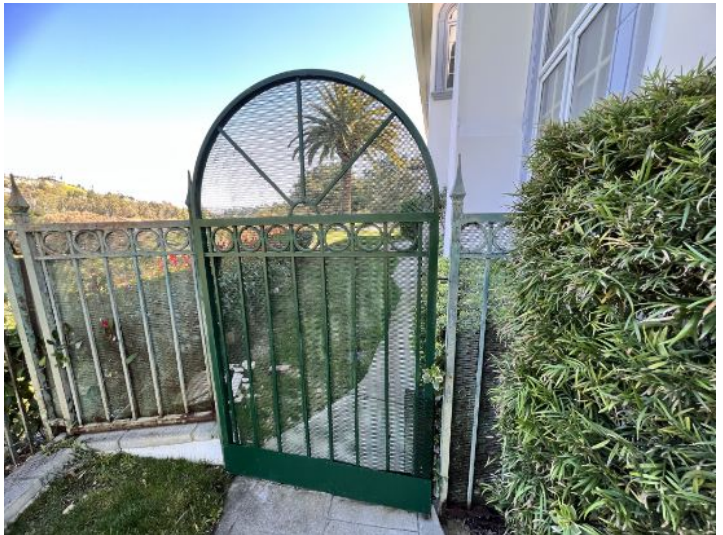
- Current safety standards require an alarm on any door leading to the pool area in order to alert adults that children may have entered the pool area. In addition, any/all gates leading to the pool area should pull out, self close and latch for safety. I recommend a qualified contractor correct as needed before close of inspection contingency period.
- The pool equipment area, including pumps, filter, electrical, etc. was not enclosed and was easily accessible to children. Safety concern. I recommend enclosing the area to help prevent children from entering the area.

The pool equipment should be enclosed for safety Gates leading to the pool area should pull out, self close and latch for safety

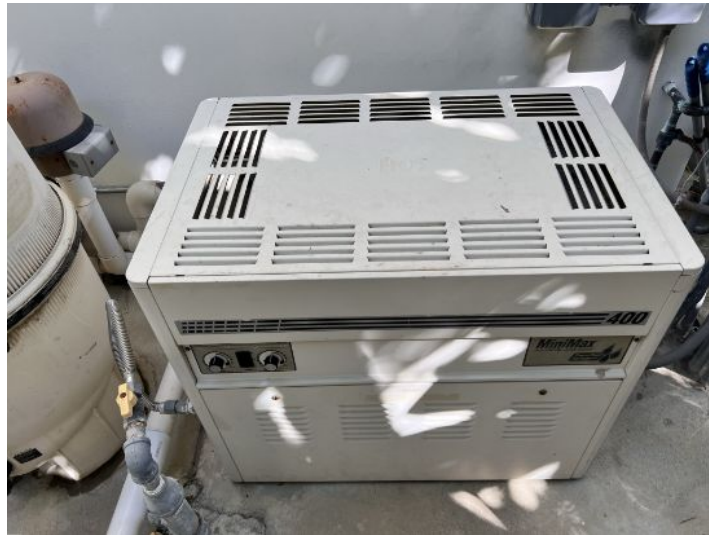
- The pool heater did not operate when tested. I recommend further review by a qualified pool contractor.

The pool heater did not operate when tested

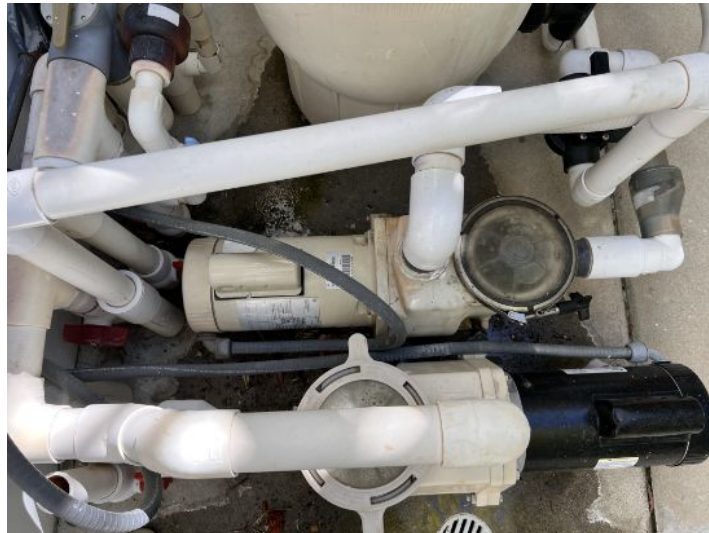
- Visible leaking around one pump. I recommend further evaluation and repair by a qualified specialist.

One pump appeared to be leaking

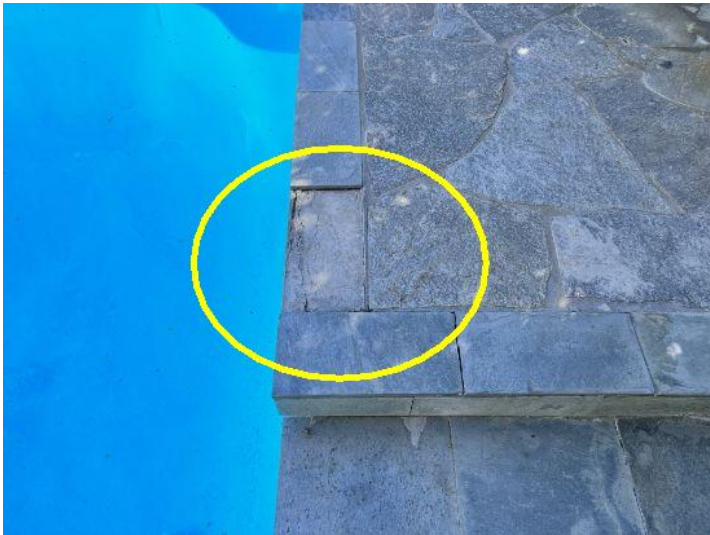
- Cracked/missing pool and pool deck tiles observed. Safety concern. I recommend repair as needed.

Missing/damaged tiles

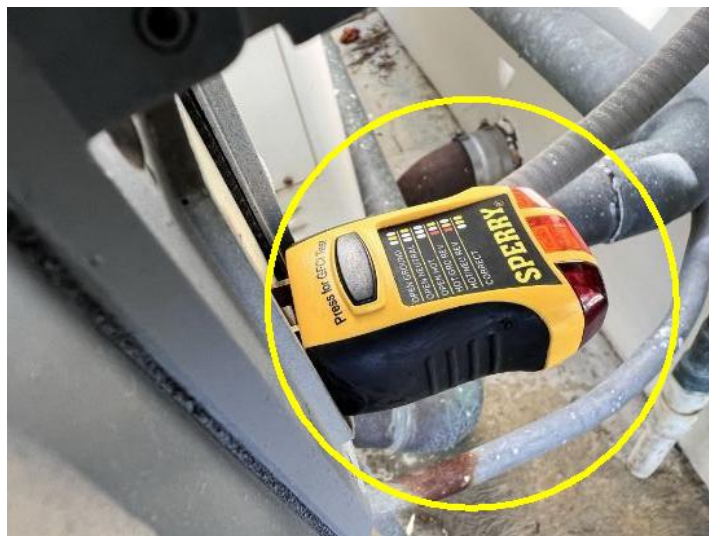
- GFCI did not respond to test. Safety hazard. I recommend further review and correction by a qualified electrician.

GFCI safety electrical receptacle was defective

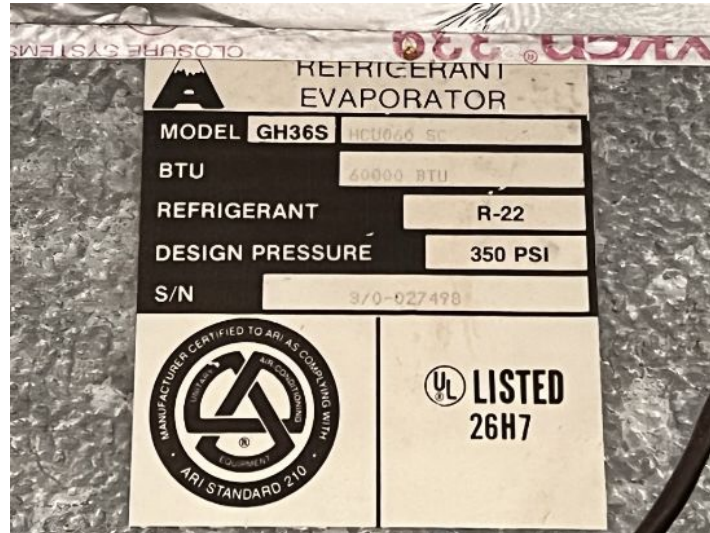
- The furnaces were older models and may be near or past the intended service life of the appliances. Although the system operated when tested, I recommend further evaluation and recommendations for upgrade by a qualified contractor.

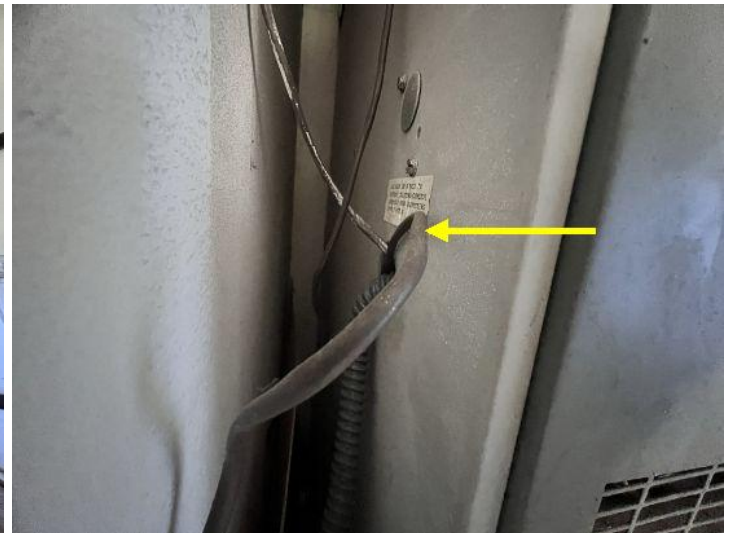
- Although it may not have been required when the house was built, a rigid gas line should be installed where it exits the furnaces. Potential safety hazard. I recommend an HVAC contractor further evaluate and upgrade as needed.

Rigid gas fitting recommended here

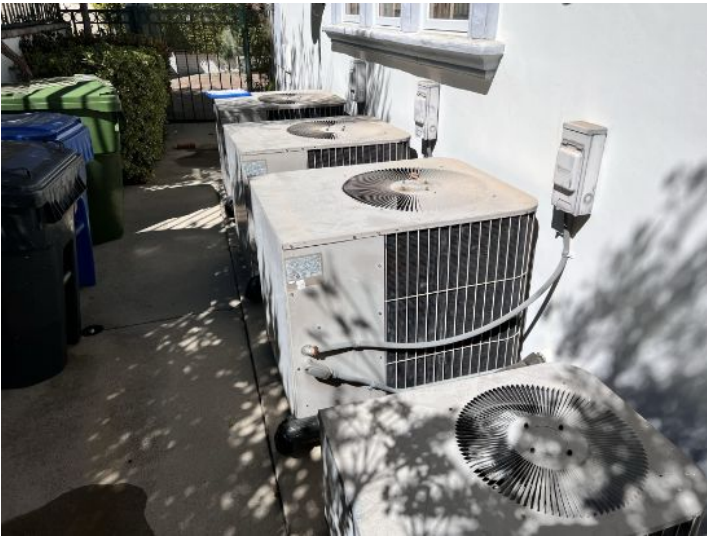
- The A/C units were older models and may be near or past the intended service life of the of 20-25 years. Replacement may be needed in the future.
- The A/C condensers were not strapped to the bases. Safety hazard in case of sudden movement, i.e, earthquake. I recommend leveling and strapping as needed for safety.

4 older A/C units had been reconditioned

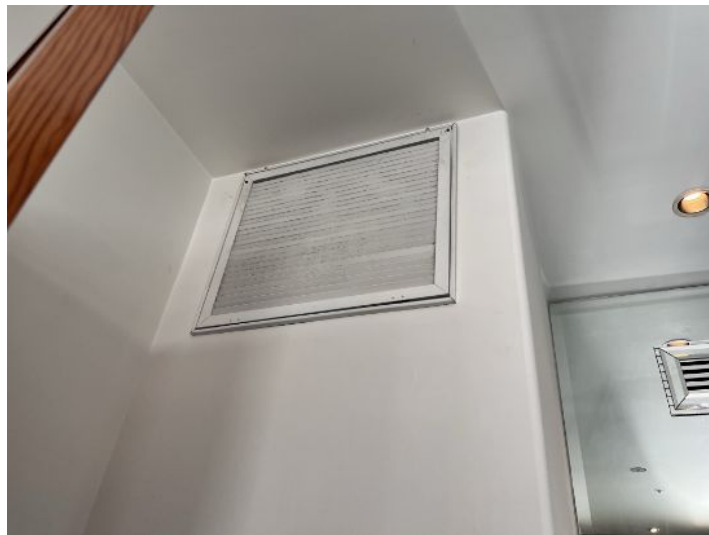
- The return air grill/filters were dirty and should be cleaned/replaced for maximum efficiency.

Air returns and filters were dirty

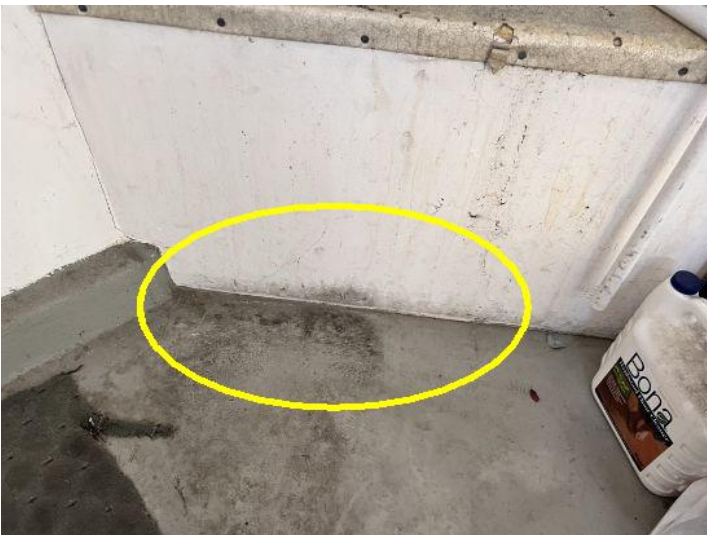
- The main house water heater drain pan did not have a long extension pipe to carry water to the exterior of the garage. In the event of water heater failure, water would discharge onto the water heater pan, then onto the floor and potentially cause damage. I recommend further review and correction by a qualified specialist.
- Microbial growth (possibly mold) was observed on the drywall water heater base. I recommend further evaluation by a specialist.

Microbial growth on the water heater base

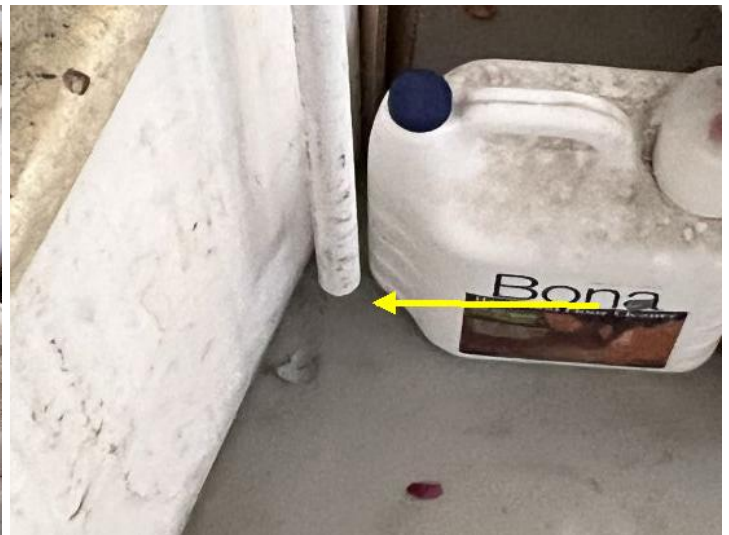
A drain pan extension pipe is recommended

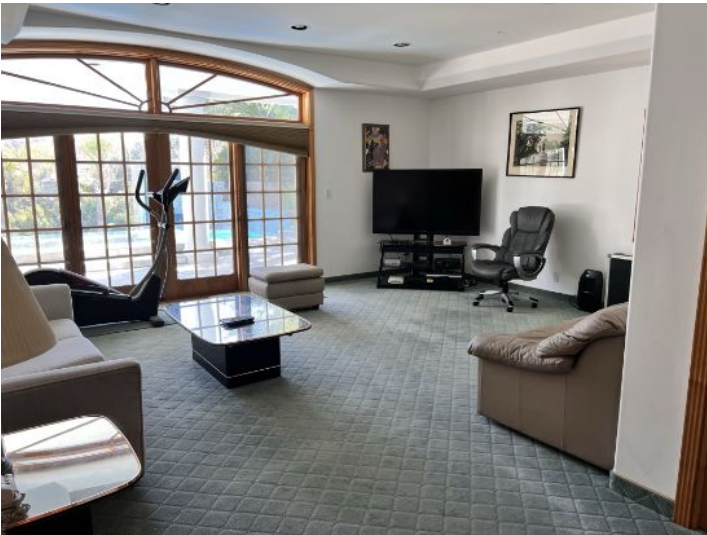
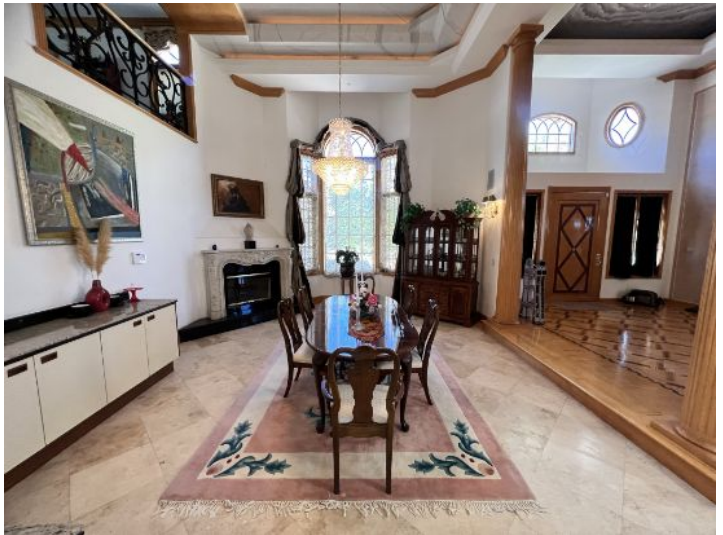
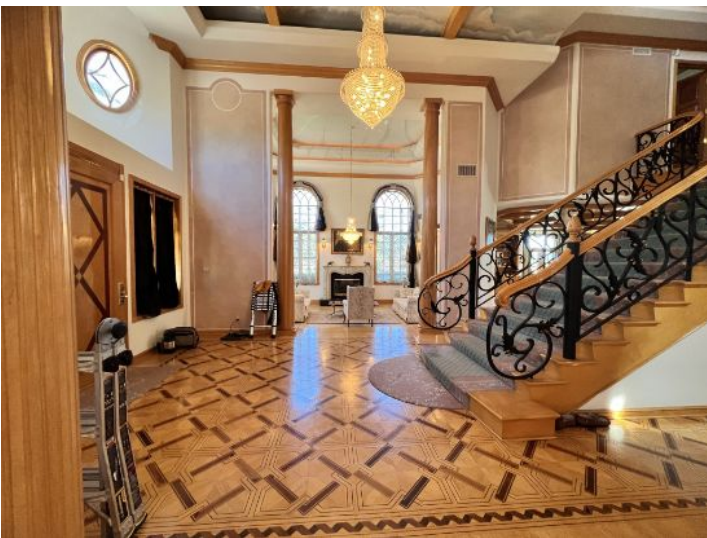
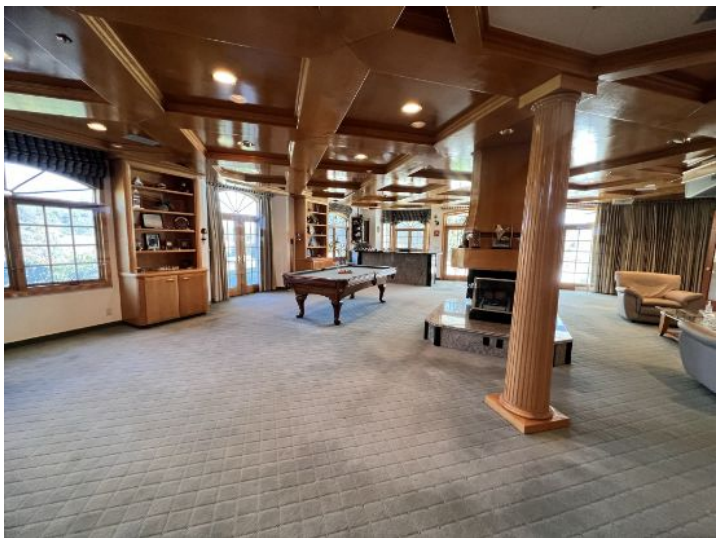
- The wood flooring downstairs was damaged/cracked near the entry. I recommend further evaluation and recommendations for repair by a qualified contractor.

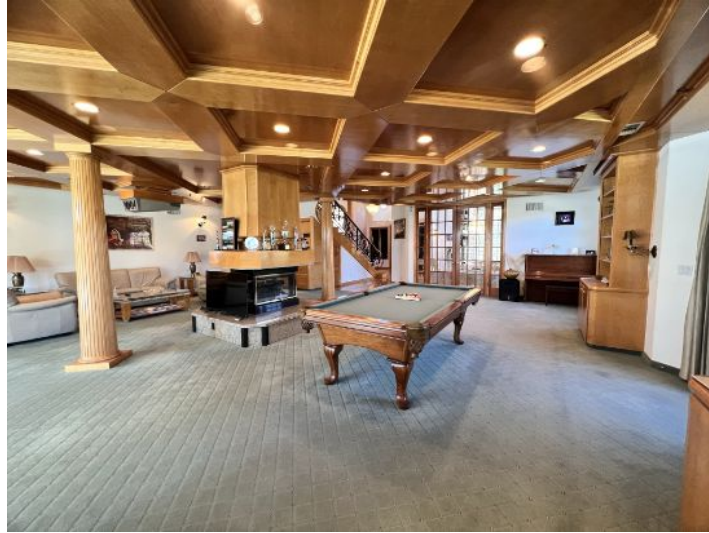
- Several cracks were observed on the interior walls/ceiling (upstairs). I recommend further review and recommendations for repair by a qualified contractor.

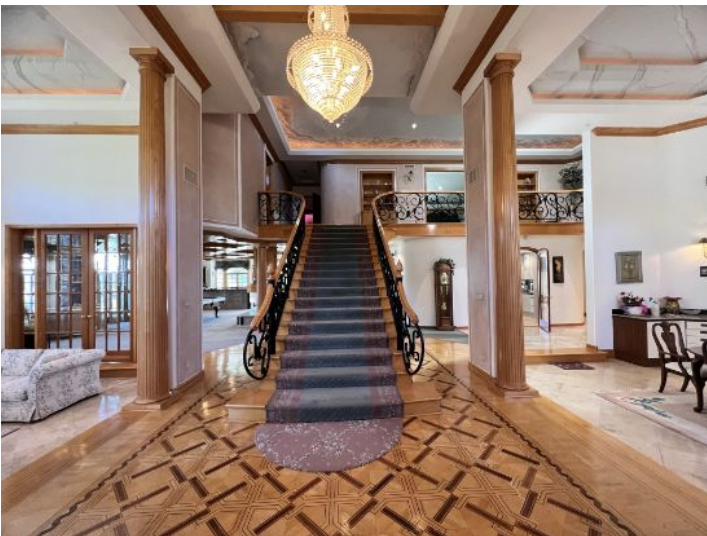
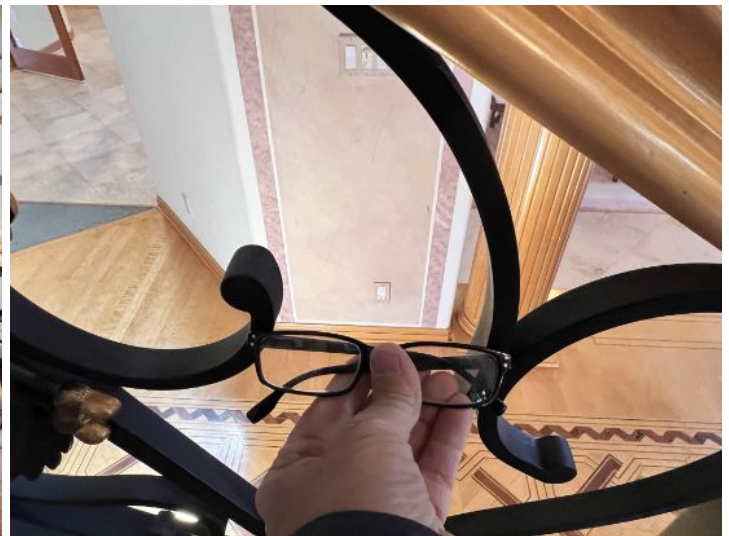
- Gaps between the ornamental iron staircase were over 4 inches wide. Safety concern for children/pets. I recommend correction by a qualified contractor.

Gaps were too wide and may be a hazard for kids and pets

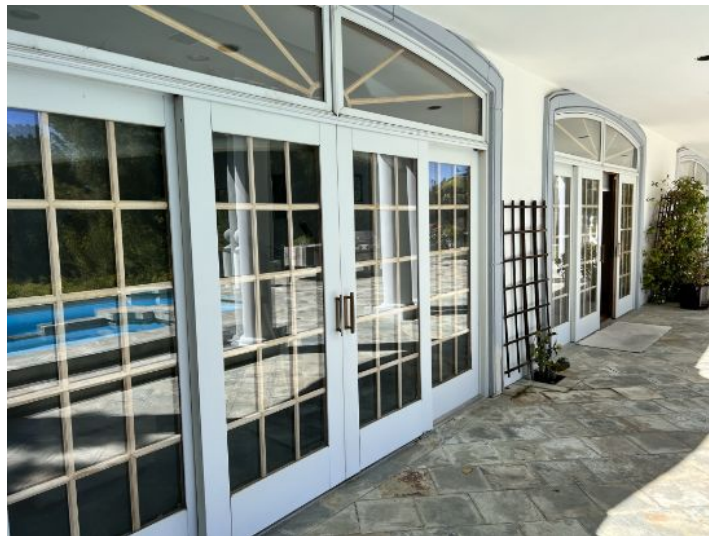
- The sliding patio doors (facing the pool area) were difficult to slide. Repair recommended.

These doors were difficult to slide

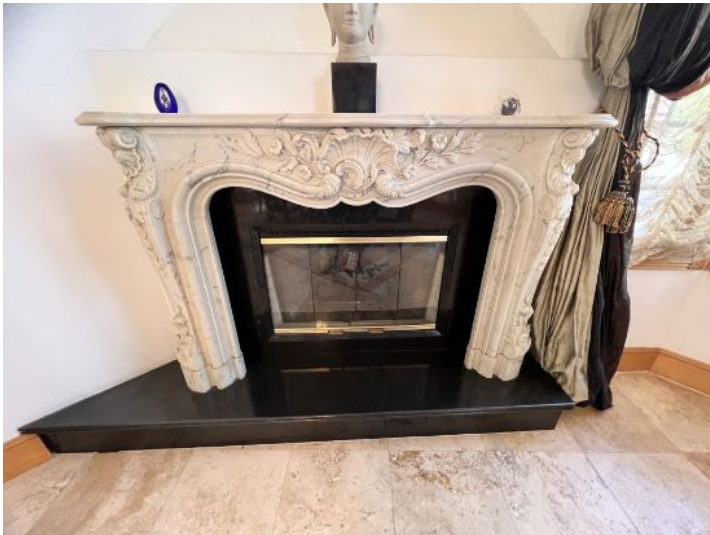
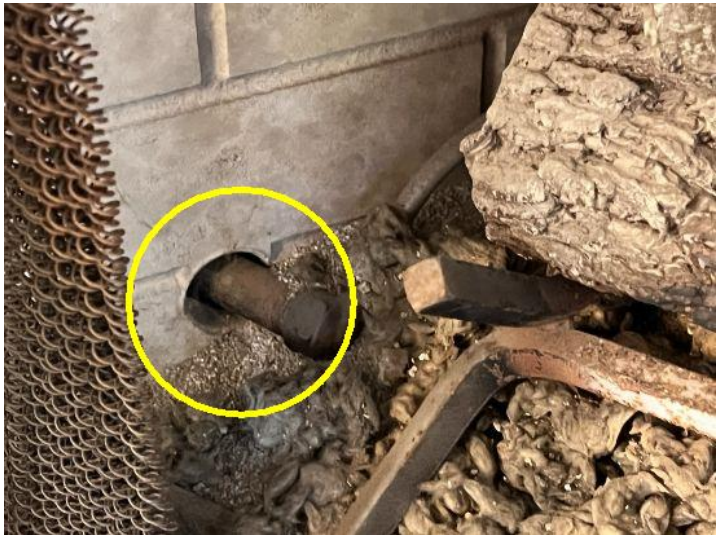
- There was a gap around the gas supply pipe(s). Repair recommended for safety.
- A damper stop was not present as required. A damper stop (clamp) helps prevent the damper from accidentally closing when using a gas fireplace, thereby helping prevent dangerous gases from entering the living space. I recommend installation as needed for safety.

This gap should be sealed for safety

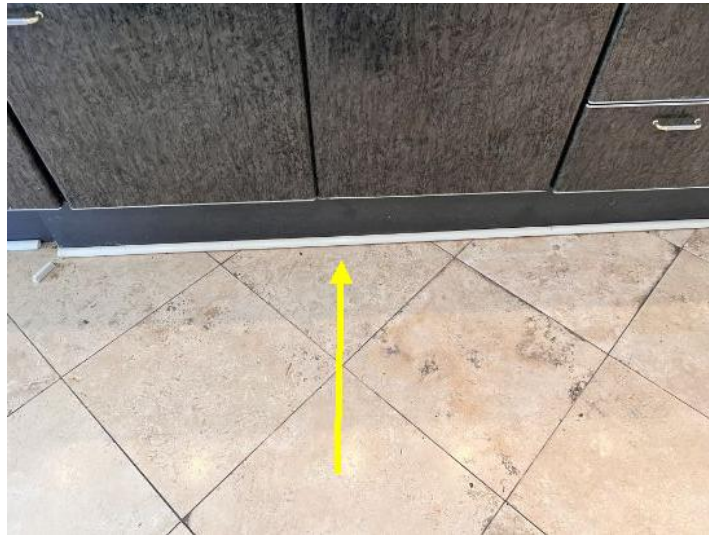
- A trim piece was detached on the bottom of the island cabinet (below the dishwasher). Repair recommended.

This trim piece was detached

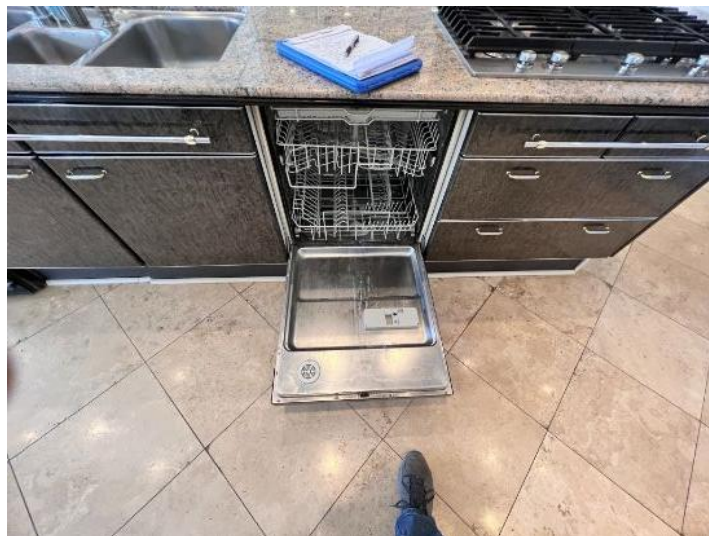
- Lack of a proper air gap noted at the dishwasher drain line. In the event of a backup/clog, the device would help prevent contaminated water from entering into the dishwasher. Some newer dishwashers have an air gap installed inside the appliance, but nevertheless, some cities/counties still require an air gap device (on the sink). I recommend having a qualified plumber further evaluate as needed.
- The dishwasher door dropped when opened. The spring was defective/damaged and repair is recommended for safety.

No spring on the dishwasher door

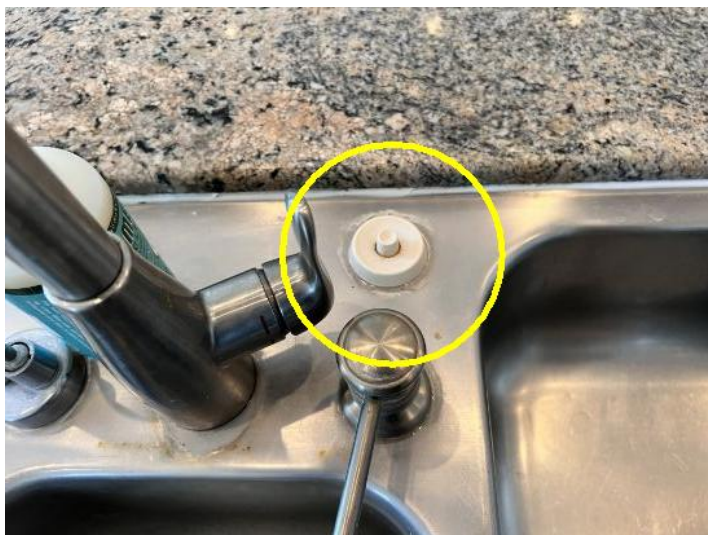
- The garbage disposal did not operate when tested. Repair recommended.

This garbage disposal did not operate when tested

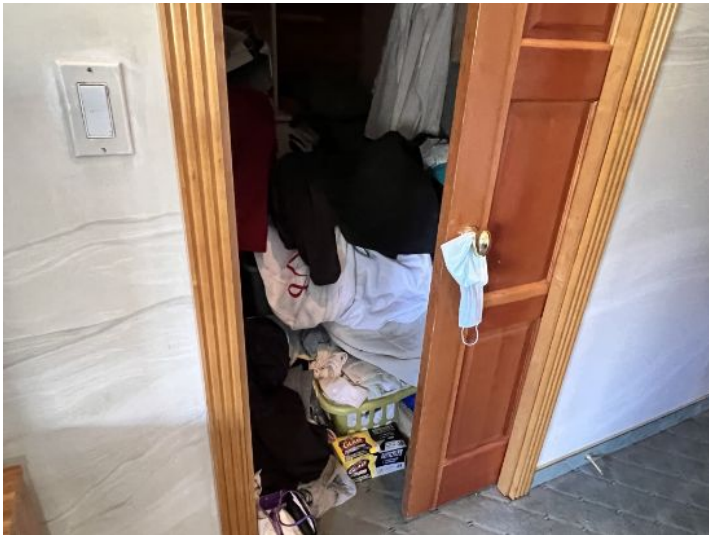
- The sliding closet door in the upstairs left office/bedroom did not close properly. Repair/replacement recommended.
- The closet door was missing in the upstairs front right office/bedroom. Replacement recommended.

This bedroom closet door was defective

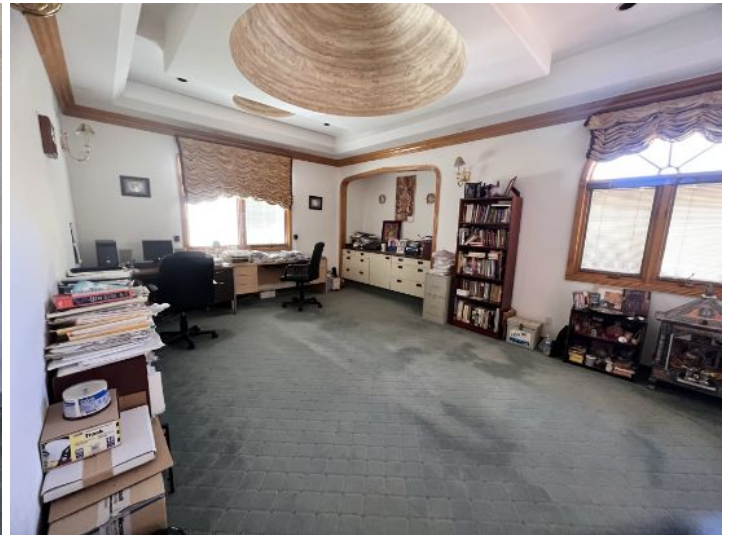
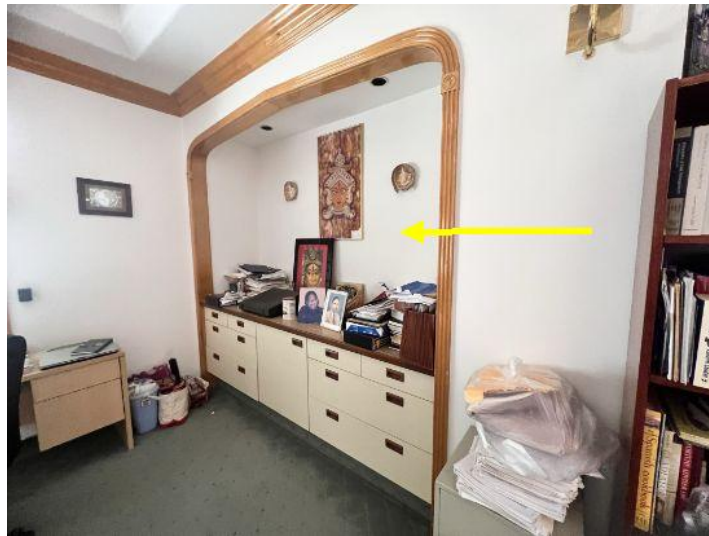
Missing closet door

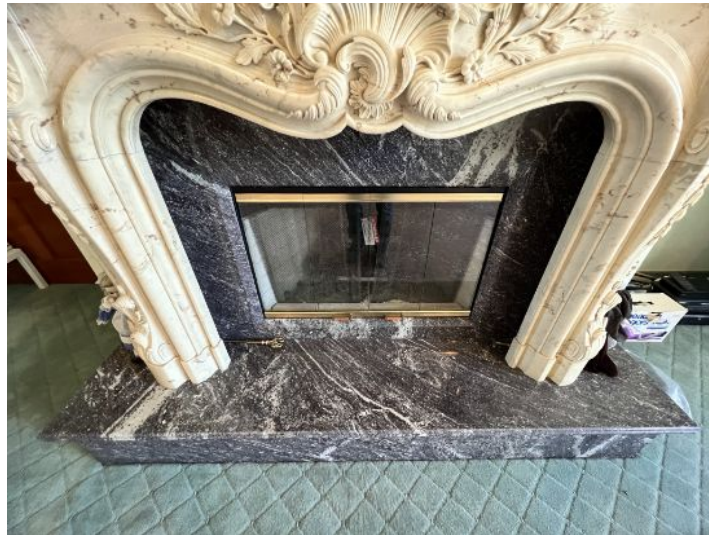
- A damper stop should be added to the gas fireplace to prevent accidental closing of the damper while in use. Safety concern. I recommend adding a damper stop as needed.
- A gap was observed around the gas pipe/fire box wall in the master bedroom fireplace. Repair recommended for safety.

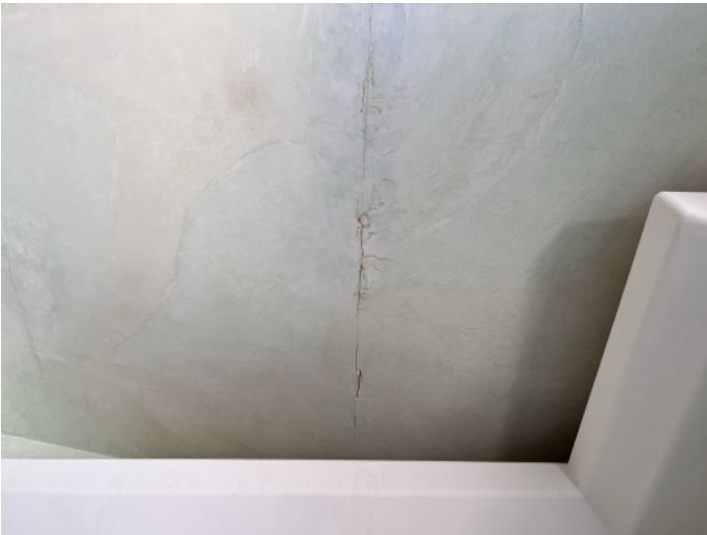
Evidence of water damage on the master bedroom ceiling

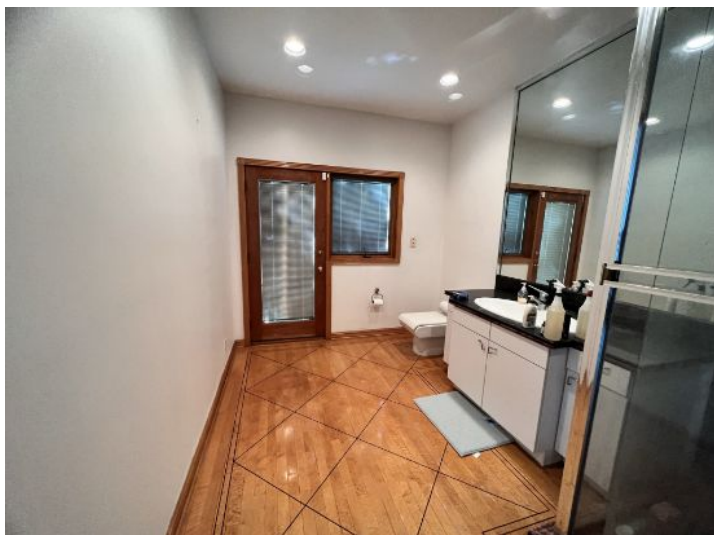
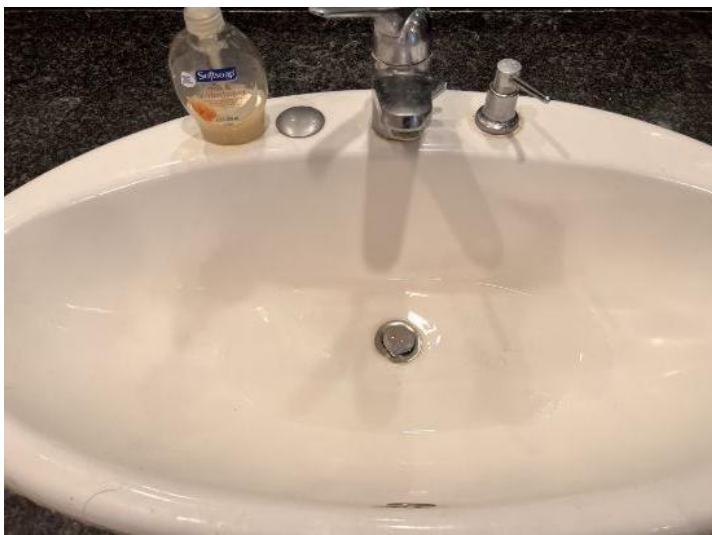
Slow drain in this sink

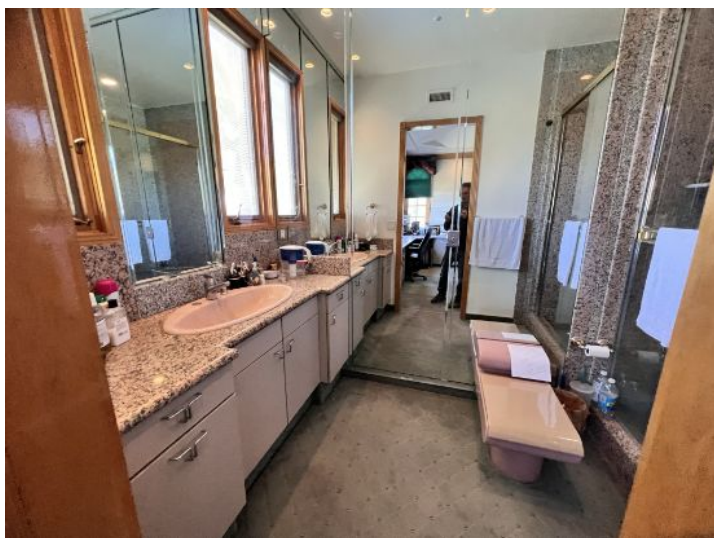
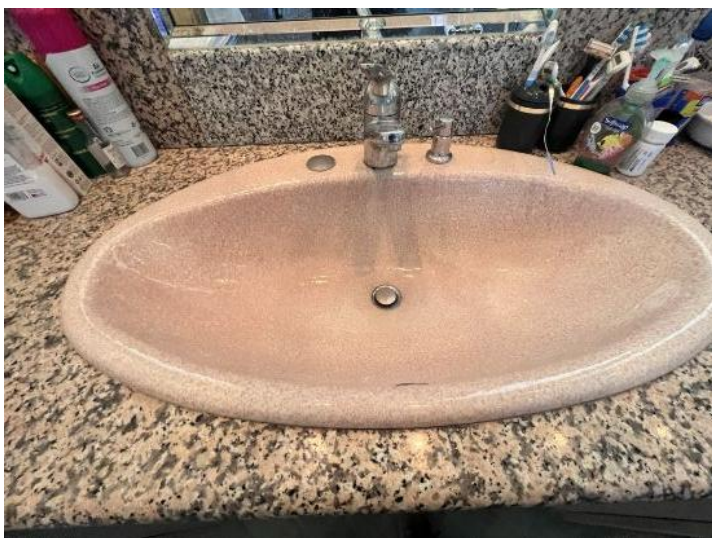
Defective sink stopper

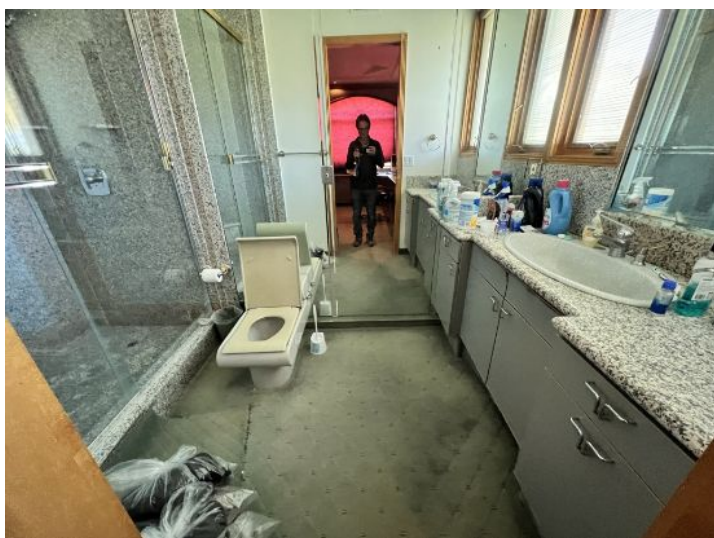
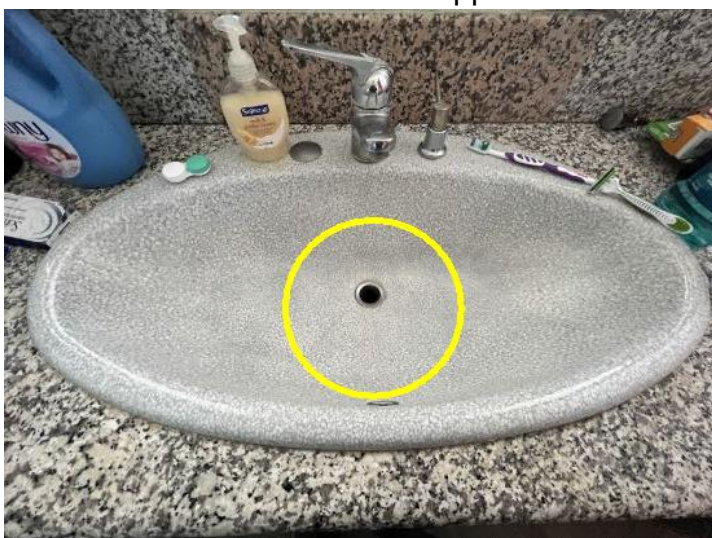
Missing sink stopper

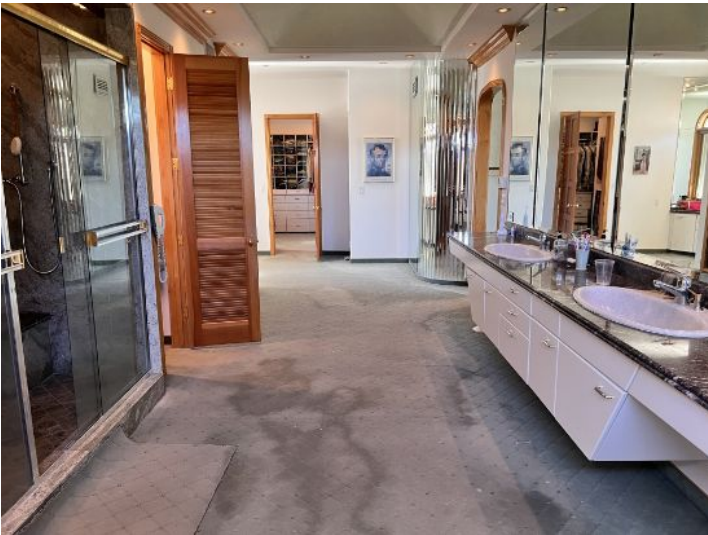
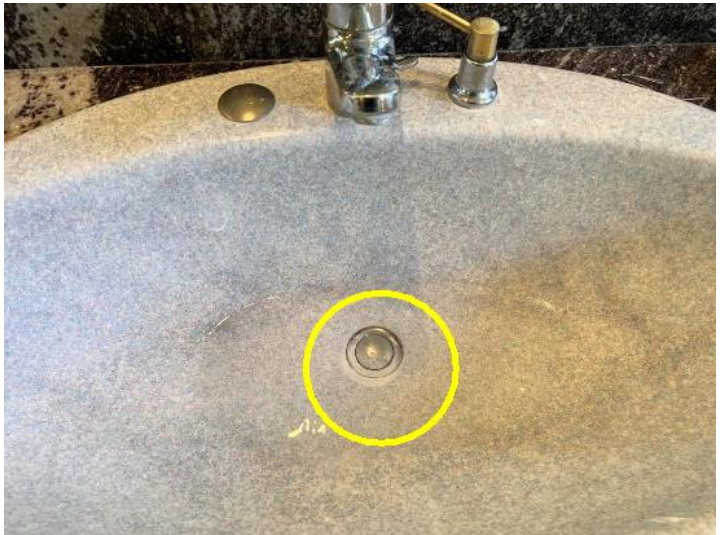
Defective master sink stopper

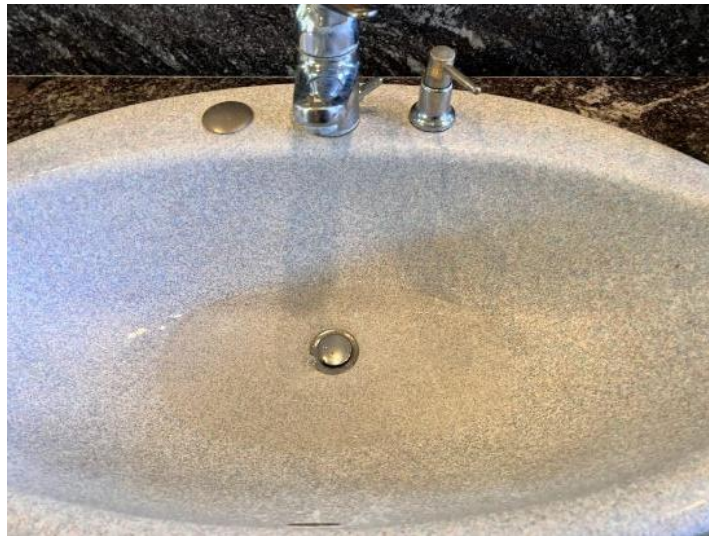
- Slow drain in the left master bathroom sink and in the downstairs TV/family room bathroom sink. Possible clog. I recommend further review and repair by a qualified plumber.
- The right sink stopper was damaged in the master bathroom. Replacement recommended.
- The left sink stopper was missing in the upstairs left/office back corner bathroom. Replacement recommended.

Slow drain in the left master bathroom sink

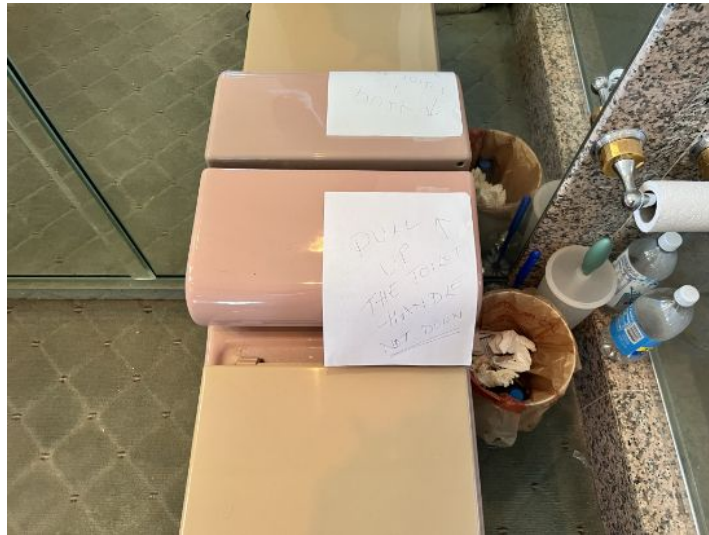
- Defective toilet handles in the downstairs hallway bathroom and in the upstairs left/office hallway bathroom. Repair recommended.

This toilet needed repair
