Cal Certified Inspections

Confidential Inspection Report

29031 Palm Drive, Calabasas, CA 91302
Inspection prepared for: Robert Black & Robin Black
Real Estate Agent: Gregory White - Calabasas Realty

Date of Inspection: 3/11/2022 Time: 10:00 a.m.
Age of Home: 1991 Size: Approximately 7493 square feet
Weather: Sunny

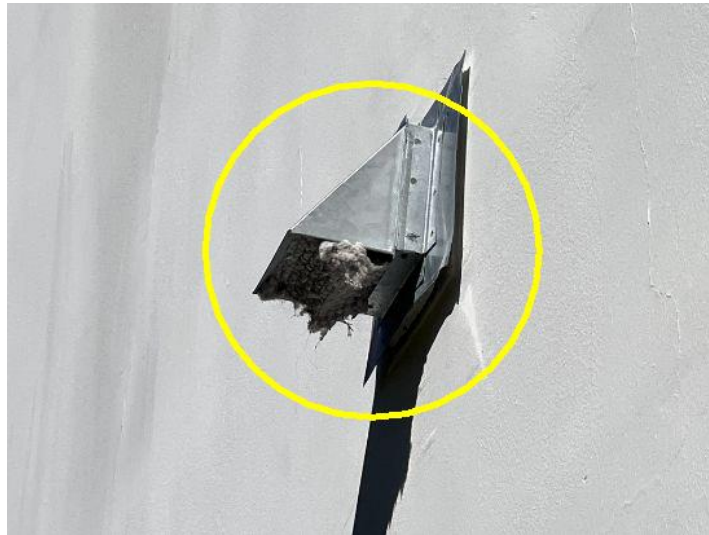
- The exterior dryer vent was clogged with lint/debris. Safety concern. I recommend repair as needed.

Clogged dryer vent
