Cal Certified Inspections

Confidential Inspection Report

29031 Palm Drive, Calabasas, CA 91302
Inspection prepared for: Robert Black & Robin Black
Real Estate Agent: Gregory White - Calabasas Realty

Date of Inspection: 3/11/2022 Time: 10:00 a.m.
Age of Home: 1991 Size: Approximately 7493 square feet
Weather: Sunny

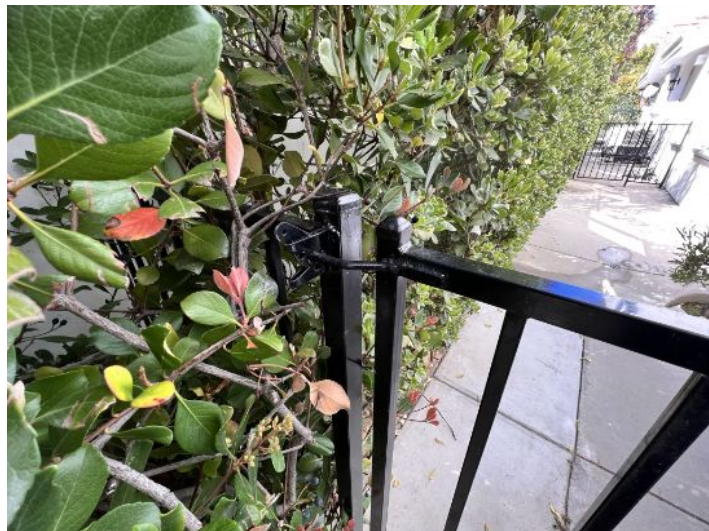
Gates leading to the pool/spa area were not to current safety codes

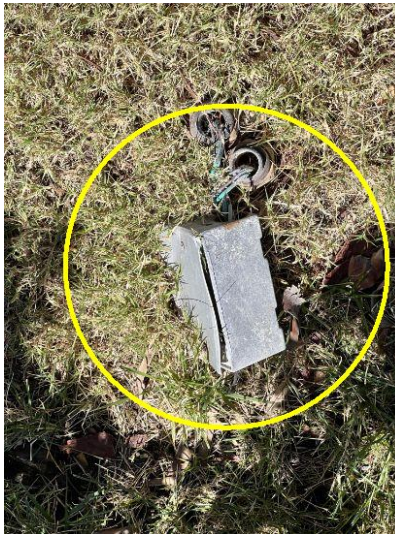
- Several landscape lights were on the ground and were loose and/or not properly covered. Exposed electrical wiring observed, which was a safety hazard. I recommend further evaluation and repair by a qualified electrician.
- At least one outdoor kitchen electrical receptacle was defective and did not include **GFCI** protection. I recommend further evaluation and repair by a qualified electrician.

Damaged landscape light

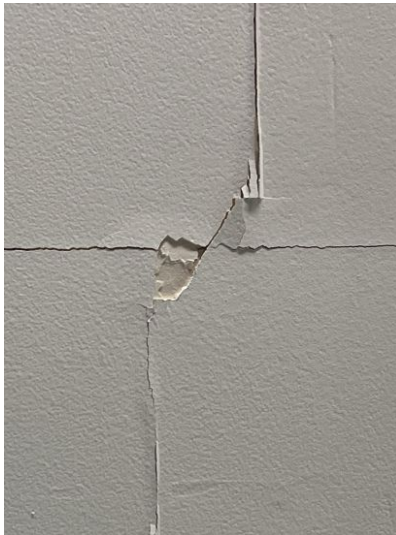
- Long cracks were observed on the drywall ceiling. Cause undetermined. Although the cracks appeared to be "cosmetic" in nature (as opposed to structural), the client may elect to have a qualified contractor further evaluate.

Cracks on the garage ceiling

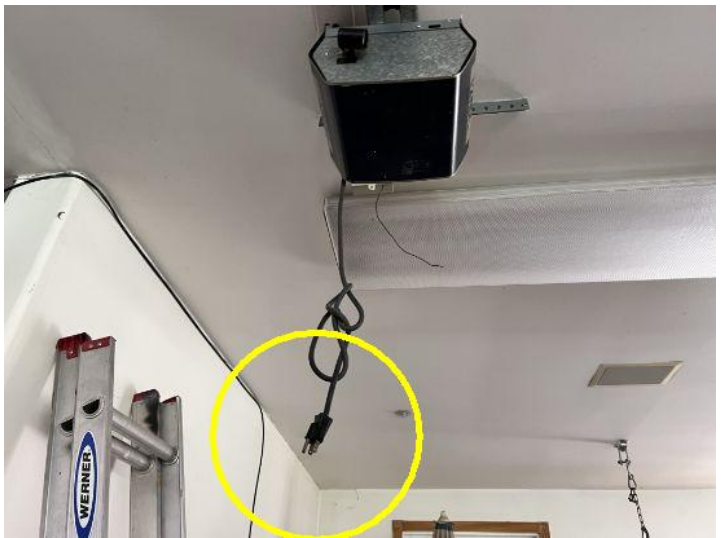
Not plugged in

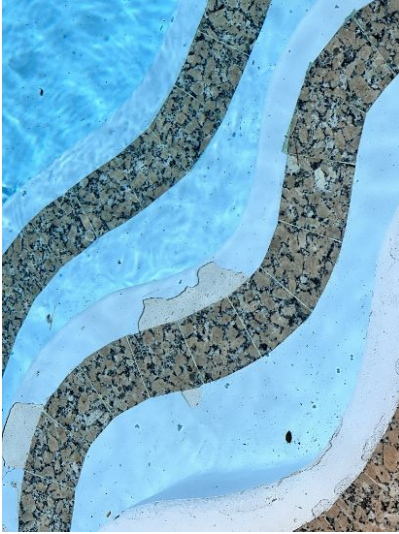
- Plaster chipping observed on the pool steps. I recommend consulting with a pool contractor for repair.

Chipped plaster on the pool steps

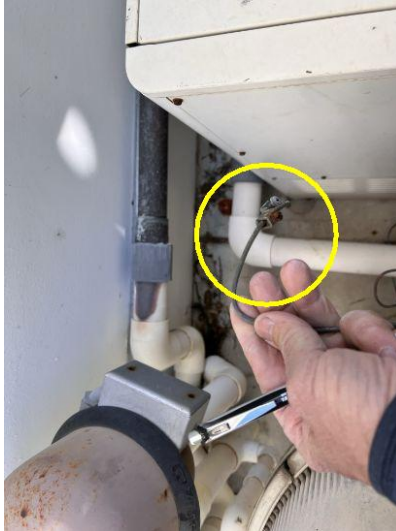
- The pool pump/equipment did not appear to be properly grounded. Shock hazard. I recommend a qualified pool electrician further evaluate and correct.

Disconnected electrical ground wires at the pool equipment

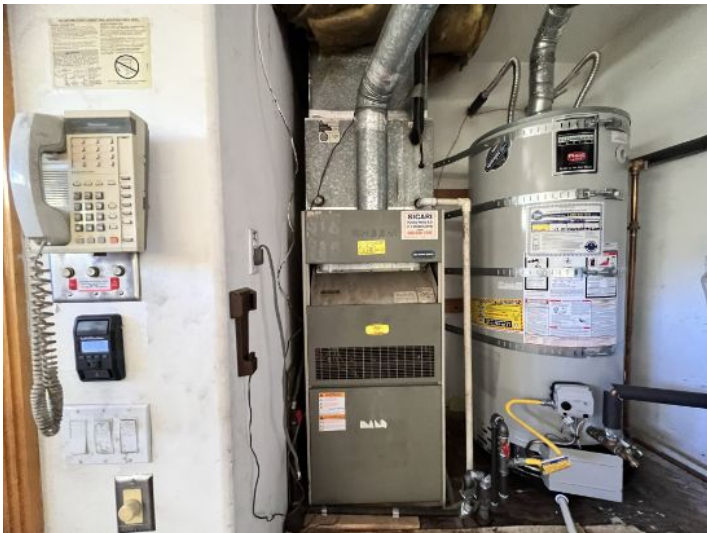
- Although it may not have been required when the house was built, a rigid gas line should be installed where it exits the furnaces. Potential safety hazard. I recommend an HVAC contractor further evaluate and upgrade as needed.

Rigid gas fitting recommended here

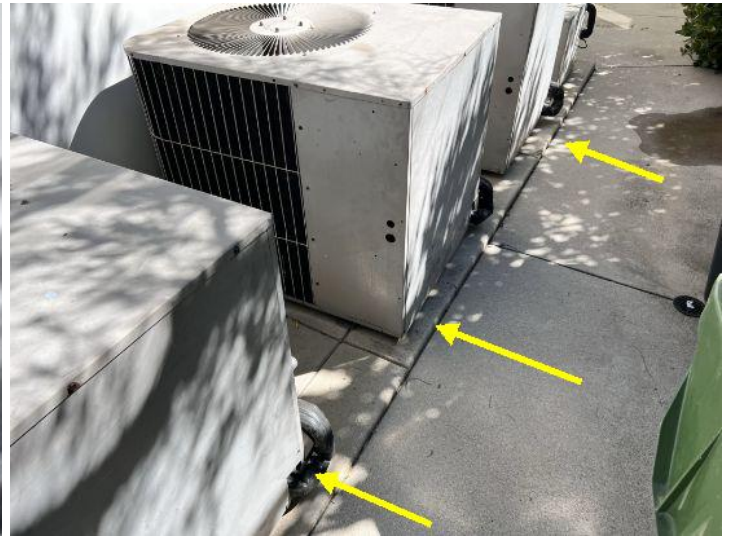
The A/C units should be strapped down to the ground for safety

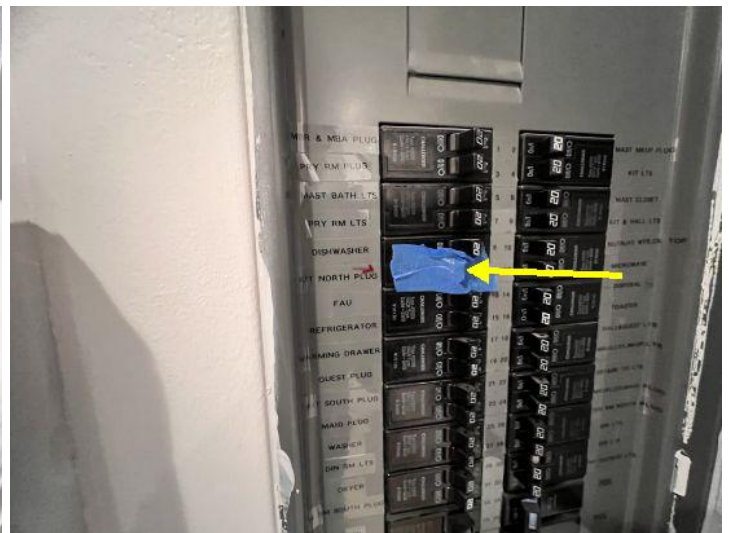
This breaker in the laundry room sub panel was in the "off" position

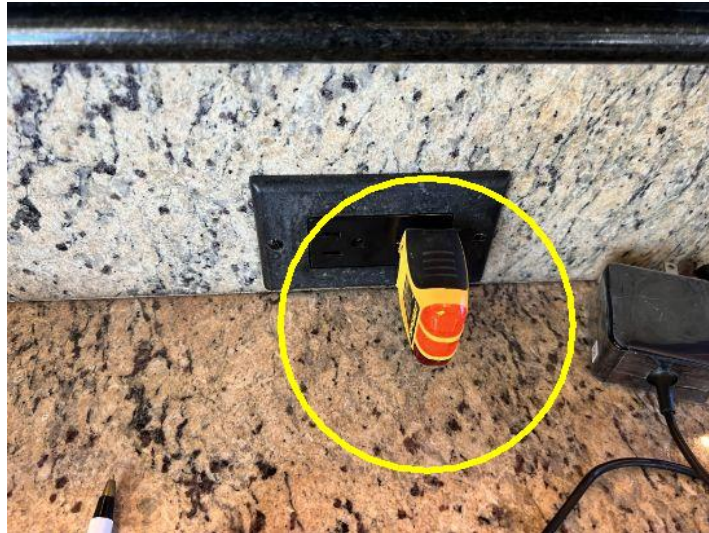
- There was a non GFCI protected outlet next to the bar sink. I recommend installation of a GFCI protected outlet to prevent shock or electrocution.

GFCI electrical receptacle needed near the wet bar sink

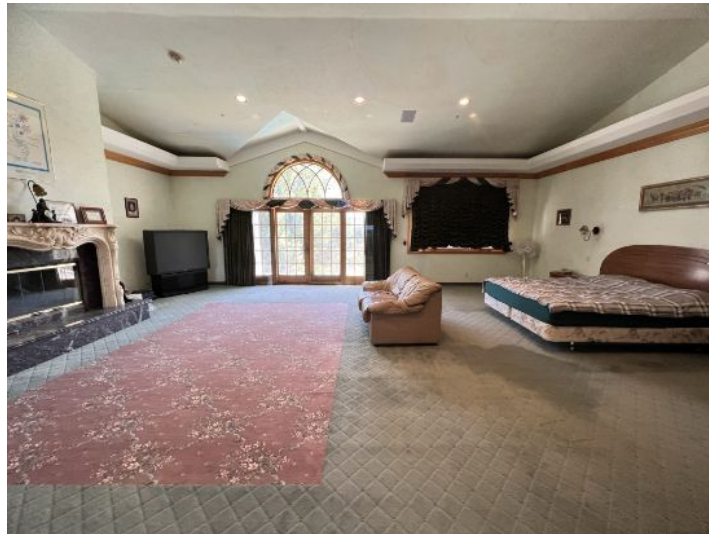
- The smoke detectors were in place during the inspection.

The bedrooms included smoke detectors
