# Cal Certified Inspections

## Confidential Inspection Report

**12345 Pacific Coast Highway, Malibu, CA 90265**  
**Inspection prepared for: John Smith & Jane Smith**  
**Date of Inspection: 1-5-2022 Time: 10:30 a.m.**  
**Age of Home: 2010 Size: Approximately 4812 square feet**  
**Weather: Sunny**

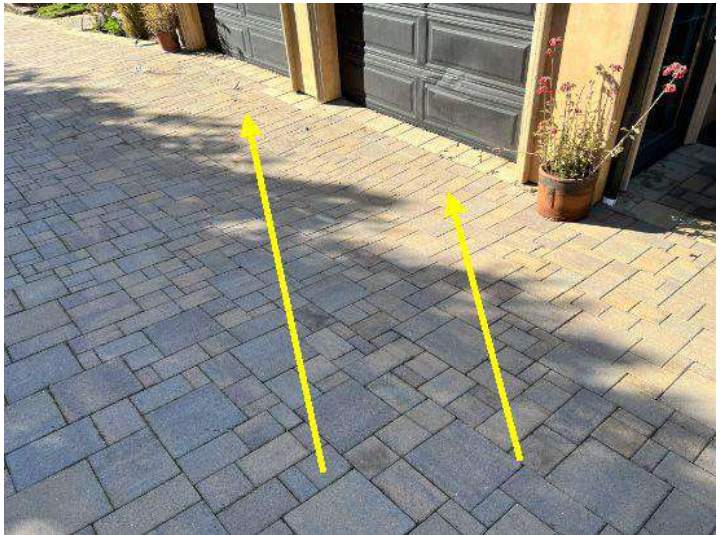
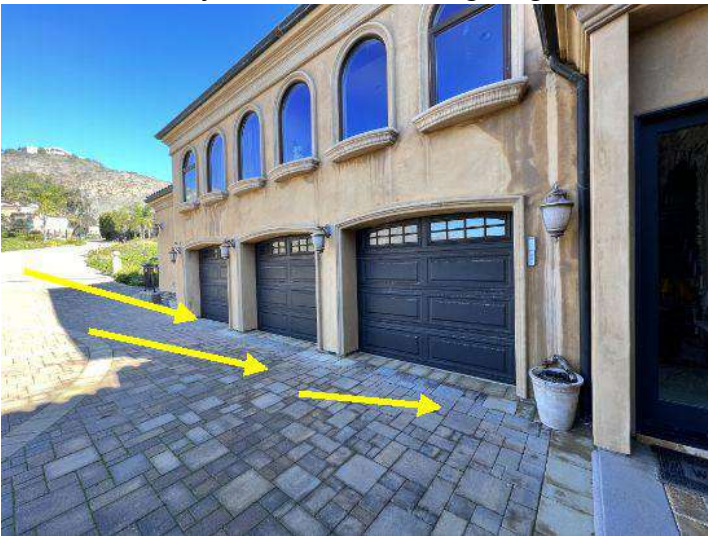
- Lot grading and drainage have a significant impact on a building, simply because of the direct and indirect damage that moisture can have on the foundation. It is very important, therefore, that surface runoff water is adequately diverted away from the home. Additionally, the property was situated on a steep hillside/canyon and it would be prudent to have a geologist fully evaluate and offer recommendations for improvement, if any is needed.
- The driveway was sloped toward the garage(s). Evidence of water infiltration was observed inside both garages. Ideally, a drain should be installed in front of both structures in order to help prevent potential water damage during rain episodes.

Water may drain toward the garage doors

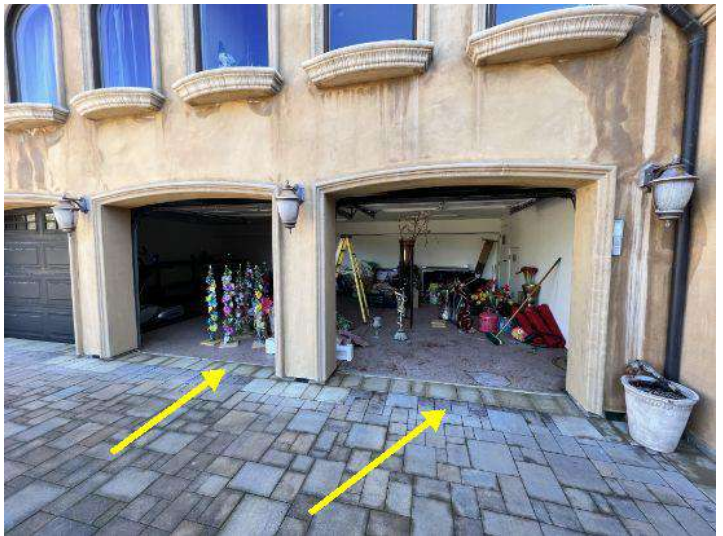
No visible drains near the main house garage doors

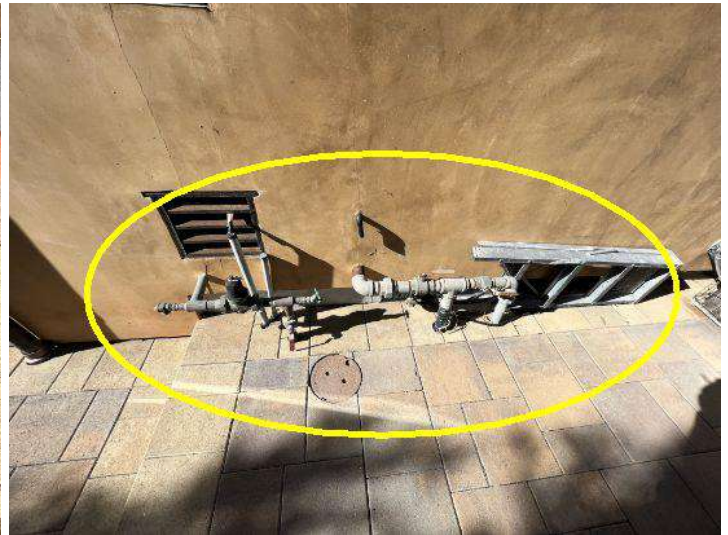
Guest house water shut off and pressure regulator shown here

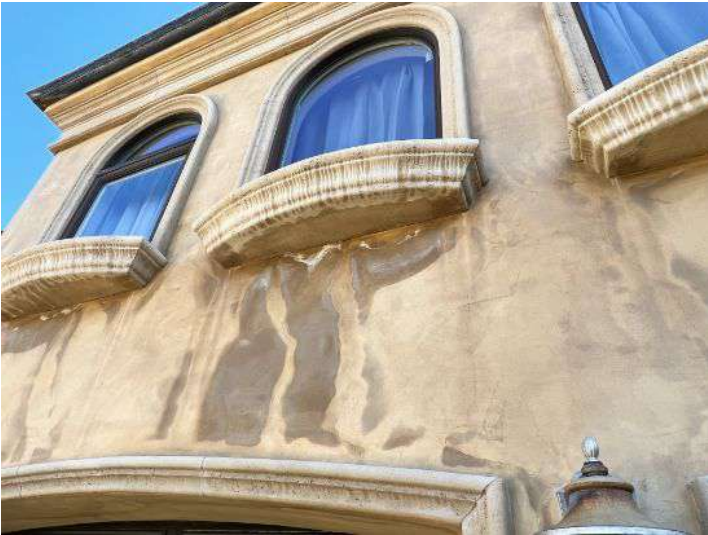
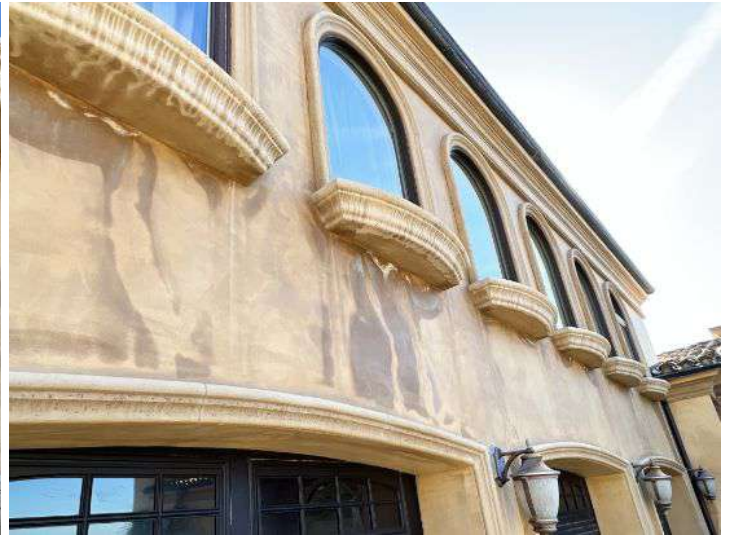
- The smooth plaster was discolored above the garage(s) and some exterior areas had small cracks which may expand if not repaired as recommended. I recommend further evaluation and recommendations for repair/correction by a qualified specialist.

Discolored plaster should be evaluated by a specialist

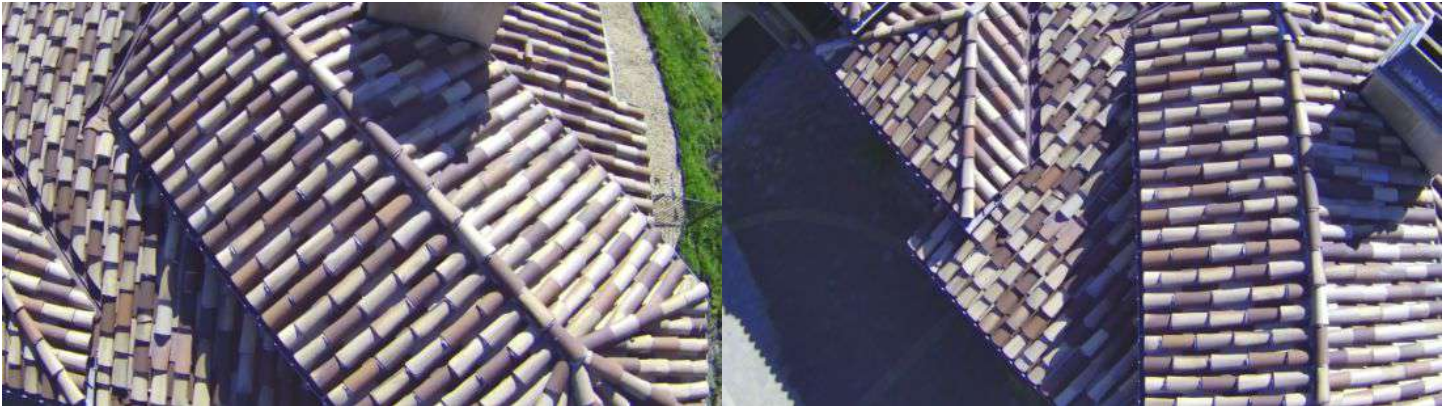
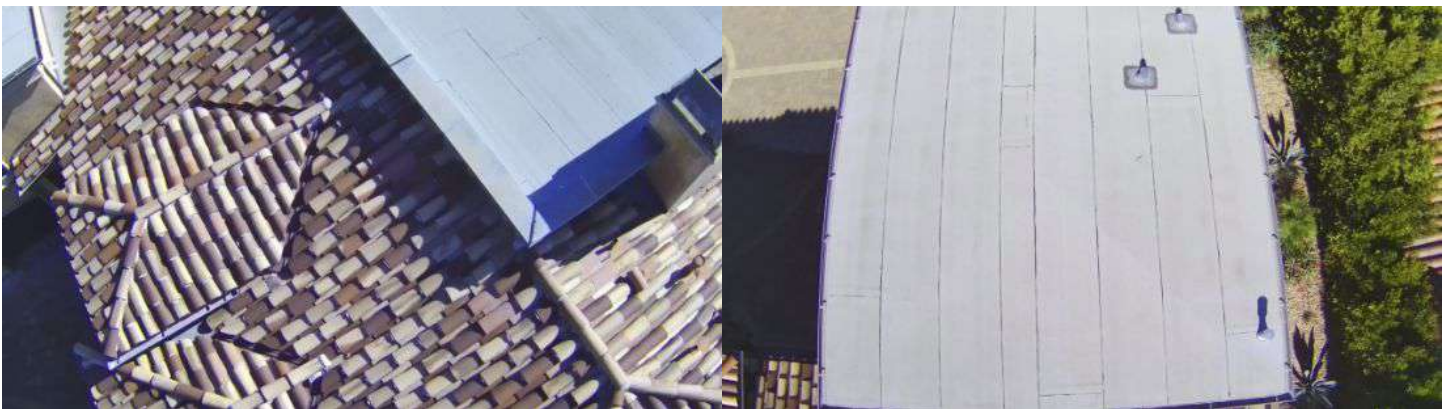
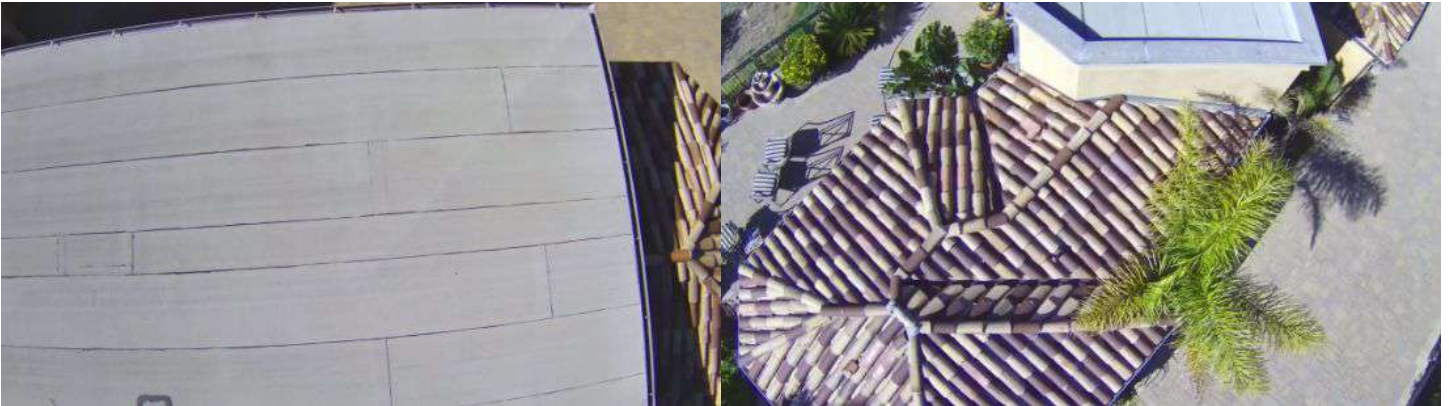
- Although the roof covering appeared to be in acceptable condition (overall), it would be prudent to obtain an evaluation by a licensed roofing contractor who would also evaluate the underlayment, which tends to decompose much faster than the visible roof covering.

Drone pictures of the roof

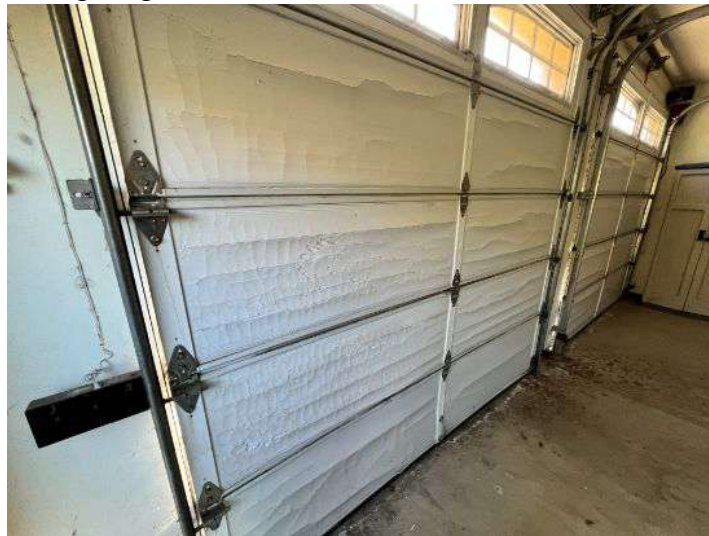
Damaged guest house garage doors

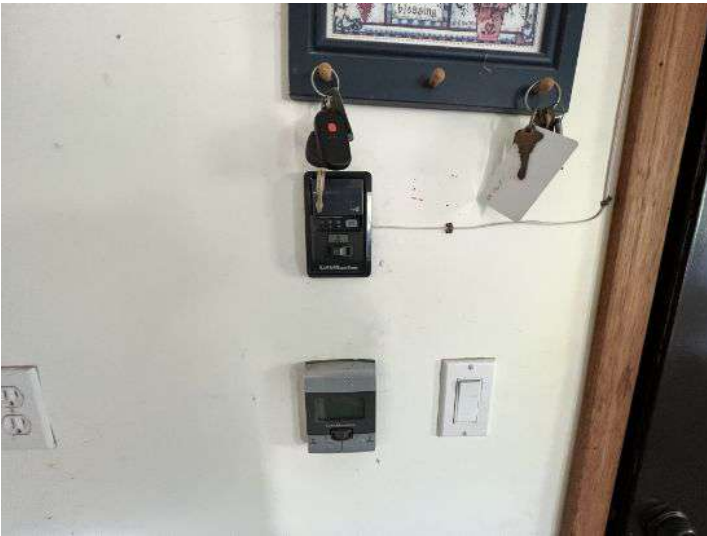
Unable to activate the guest house garage door  
buttons

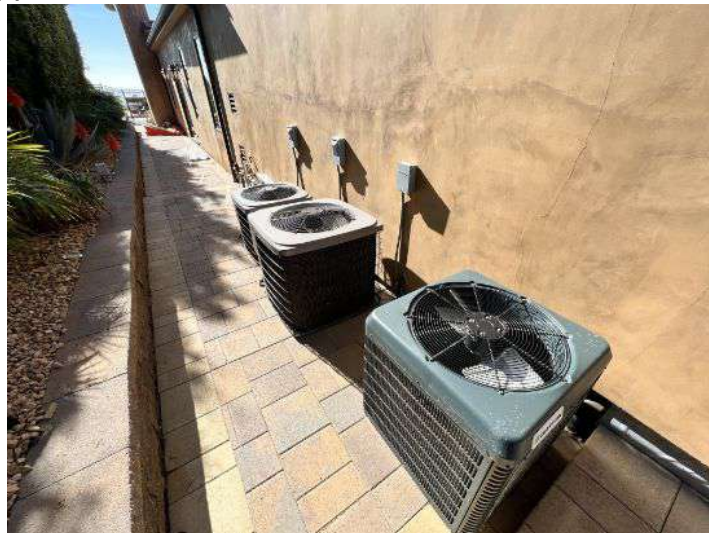
The three A/C units should be strapped down for safety

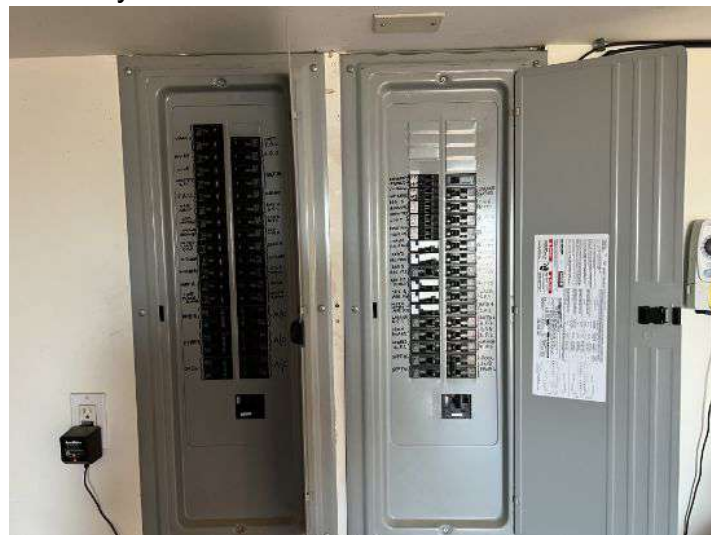
200 and 150 amp electrical sub panels located in the main house garage

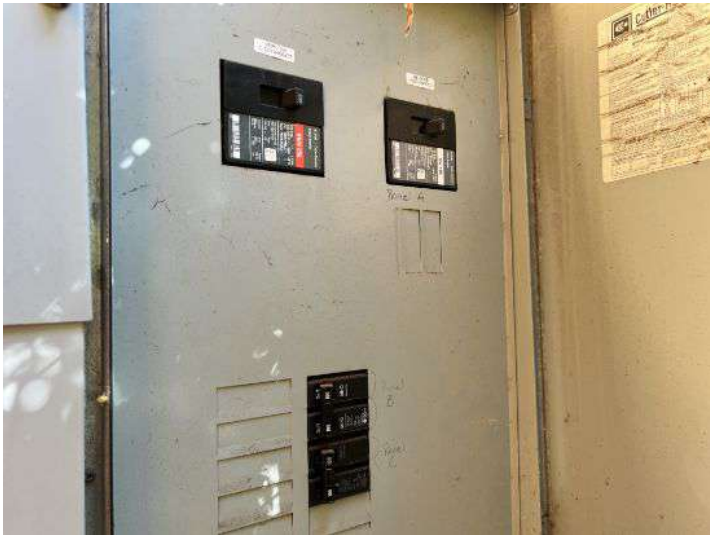
Service disconnect breakers

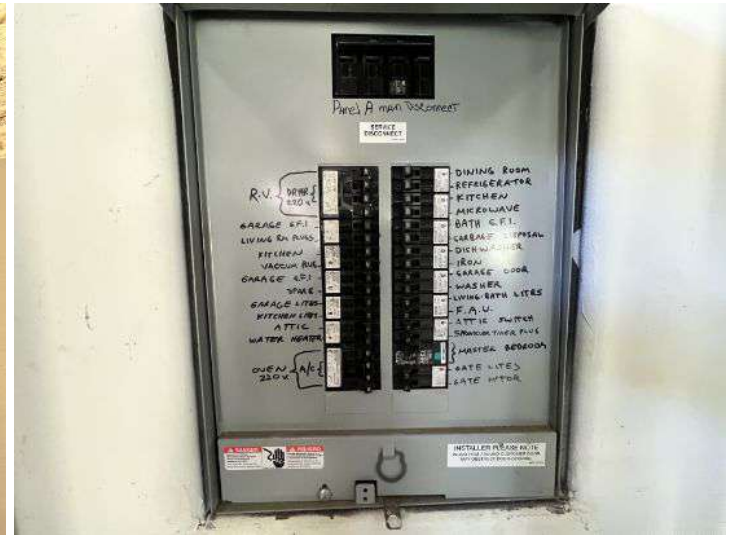
Garage sub panel breakers were labeled

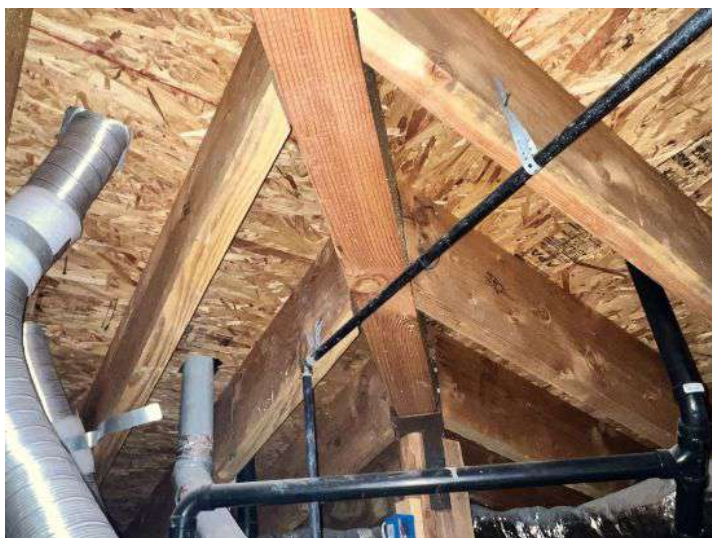
- No deficiencies observed in visible areas.

Attic structure appeared acceptable

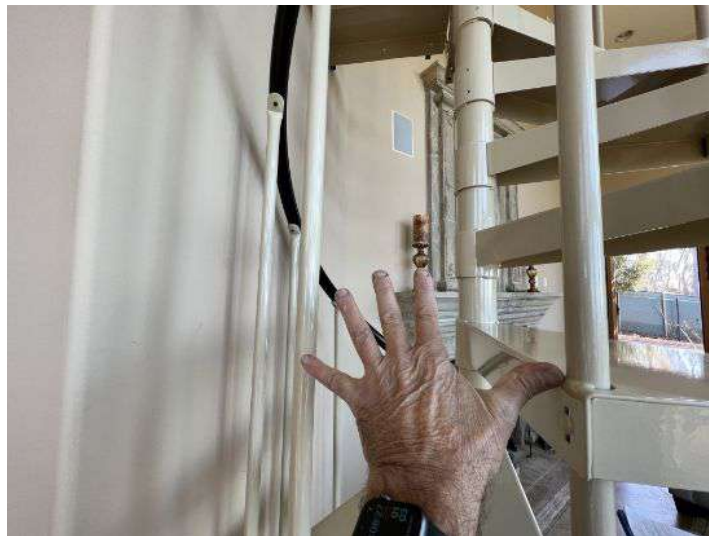
- Gaps between the staircase spindles were over 4 inches wide on the guest house spiral staircase. Safety concern for children/pets. I recommend correction by a qualified contractor.

Wide gap may be a concern for children and/or pets

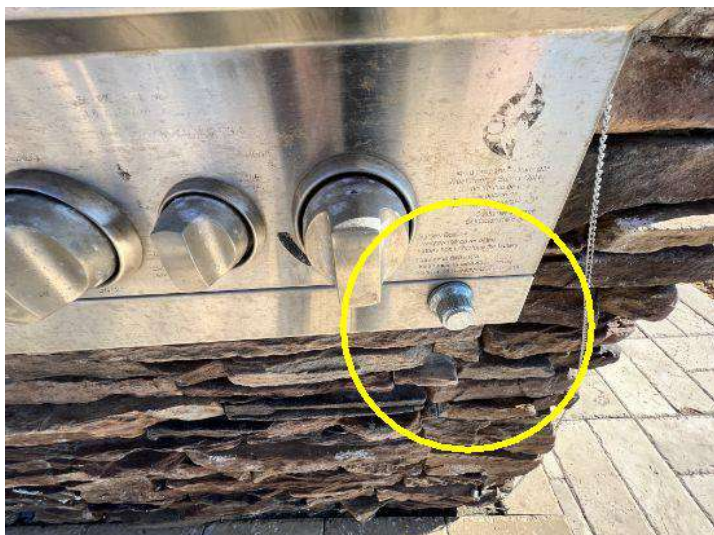
- The gas cook tops for both houses operated normally when tested.
- The pool area included an outdoor kitchen with a gas grill. The ignitor button for the grill did not operate when tested. Repair recommended.

The ignitor button did not operate

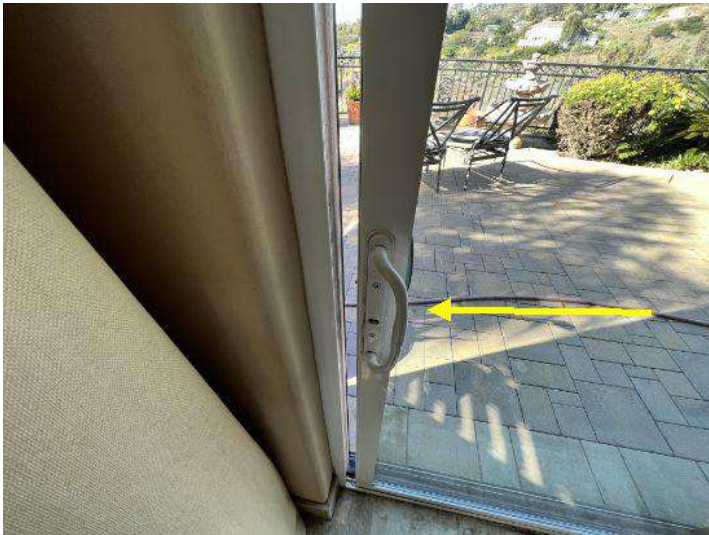
- Some sliding glass doors did not latch properly. I recommend repair as needed.

Guest house patio door did not latch

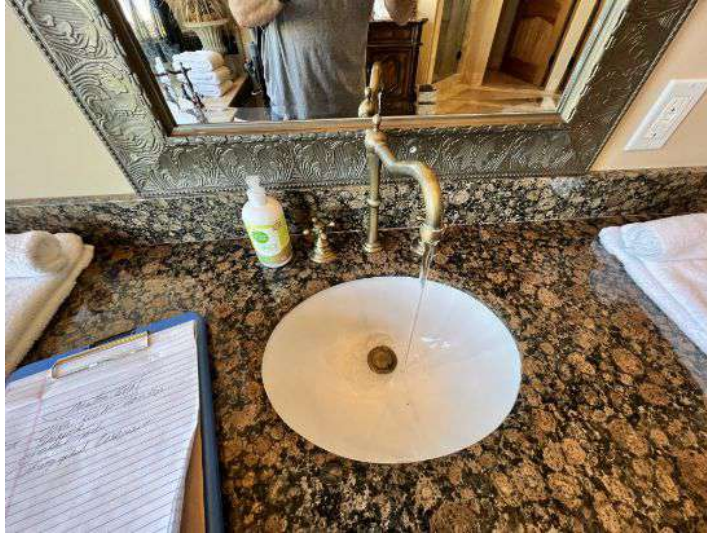
The water pipe(s) for this sink were very loud
